**RCSSS**  
CHARTERED STRUCTURAL SOLUTIONS

## Report on Structural Condition

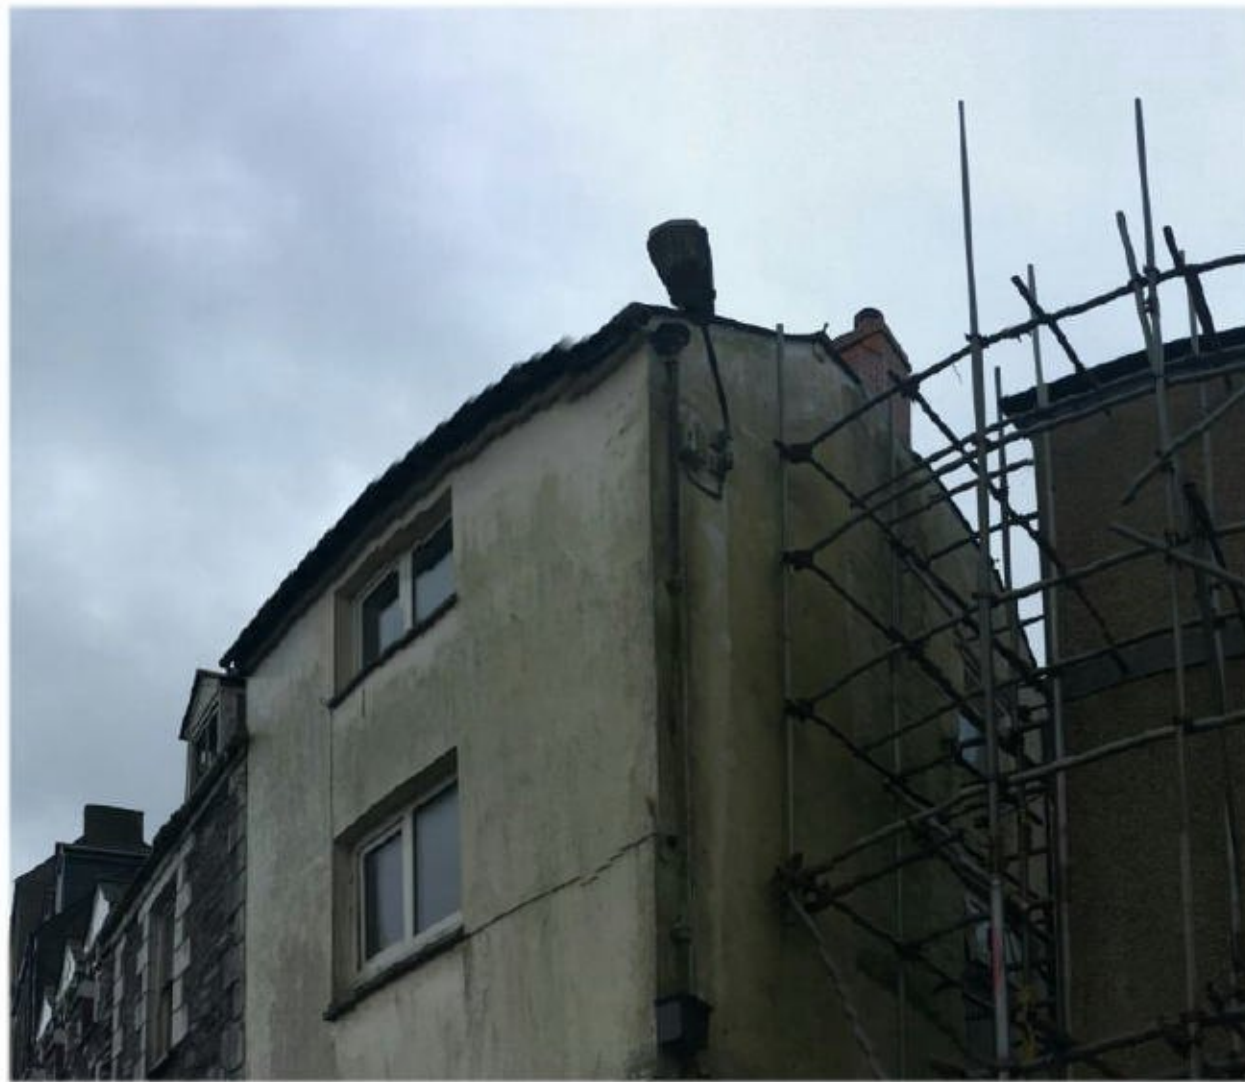
**No. 15 Polkirt Hill**  
**Mevagissey**  
**PL26 6UR**  
**Cornwall**

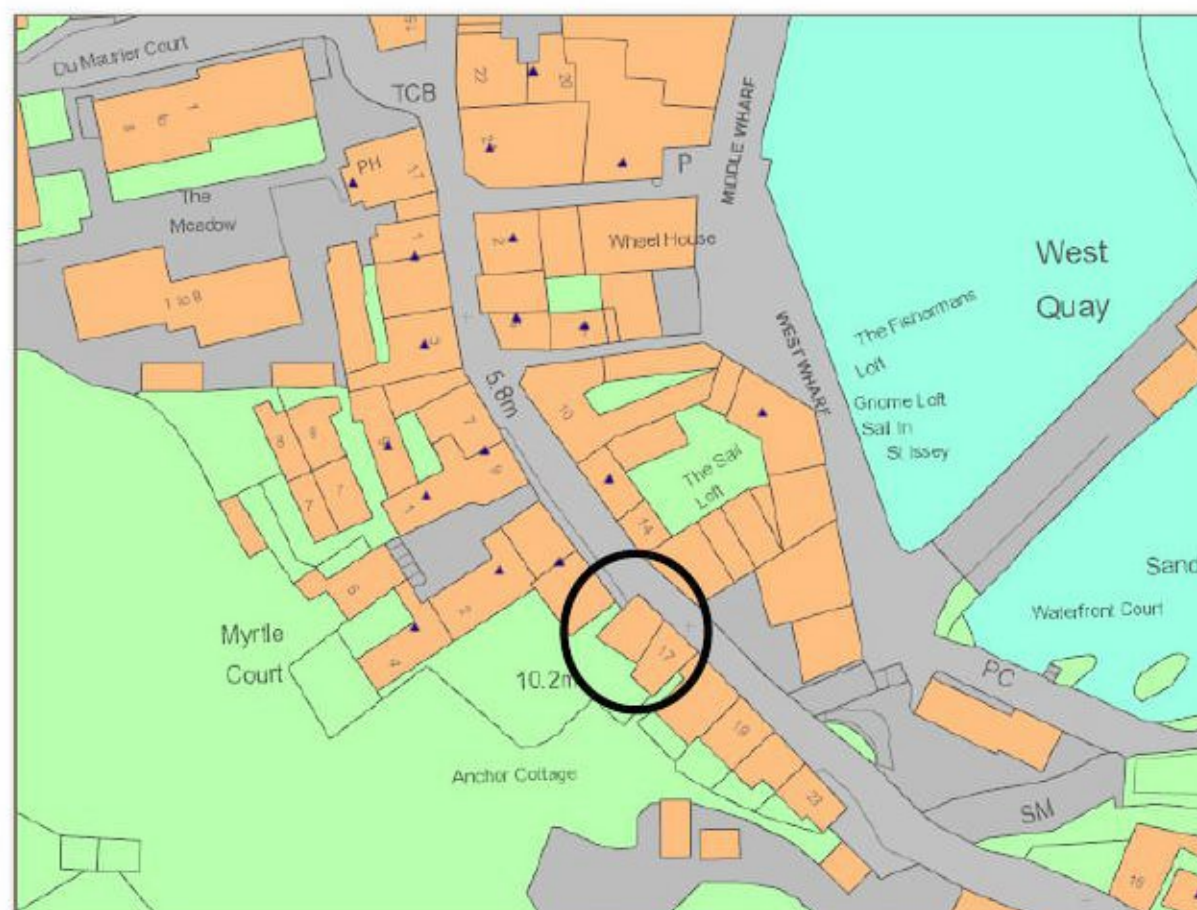
Plan-Picture 1 Property location in Mevagissey

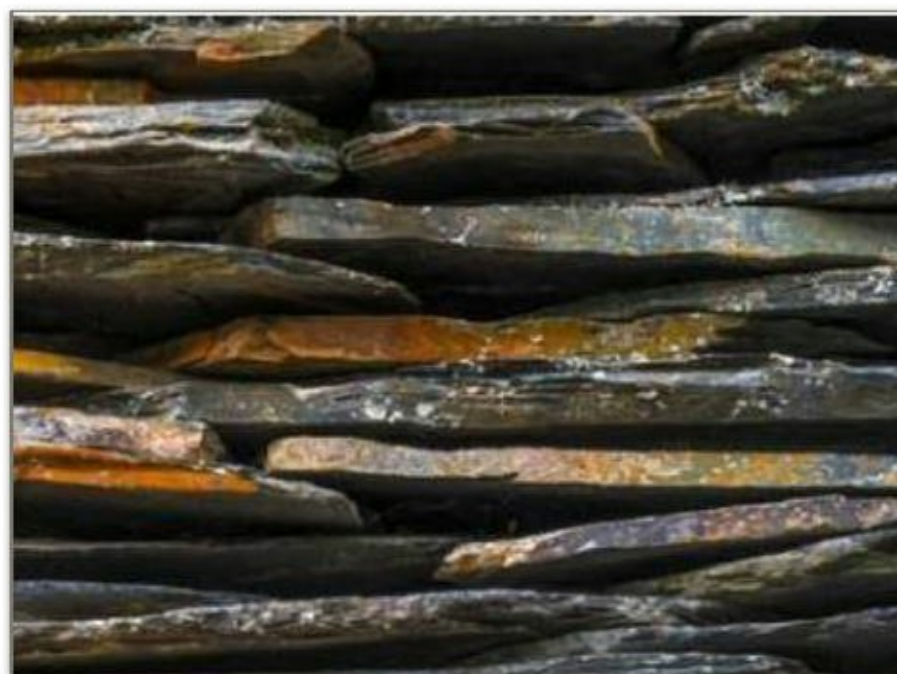
Picture 2 Shale rock

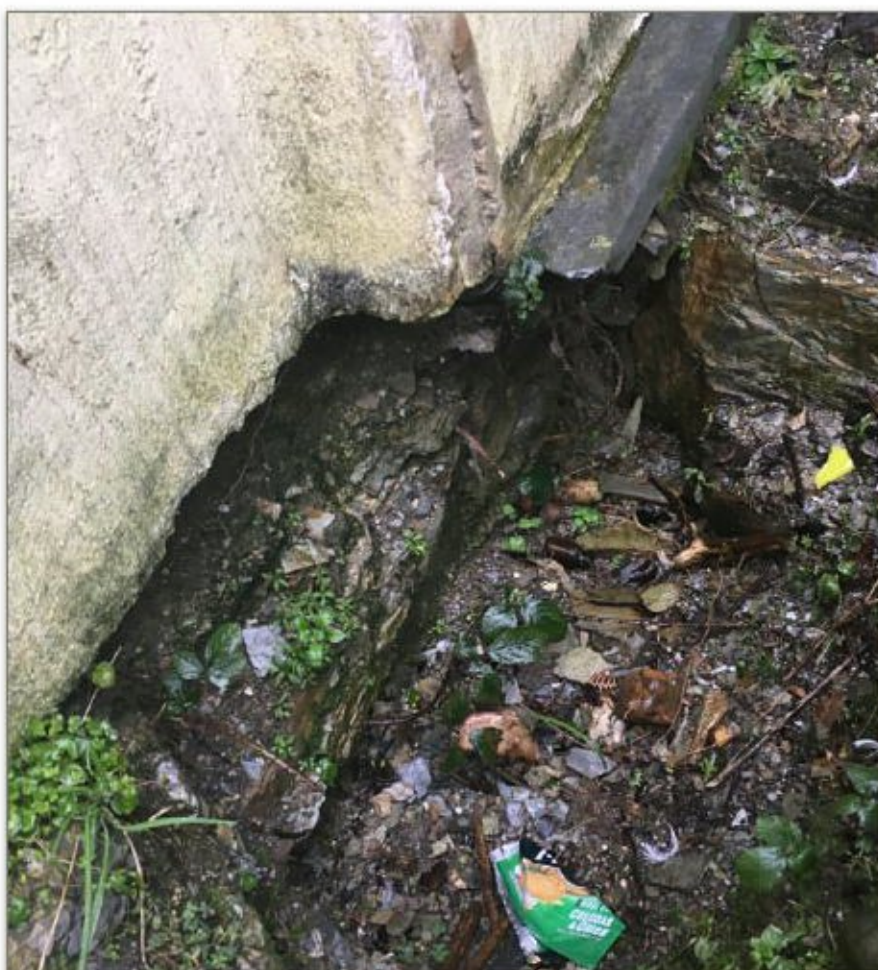
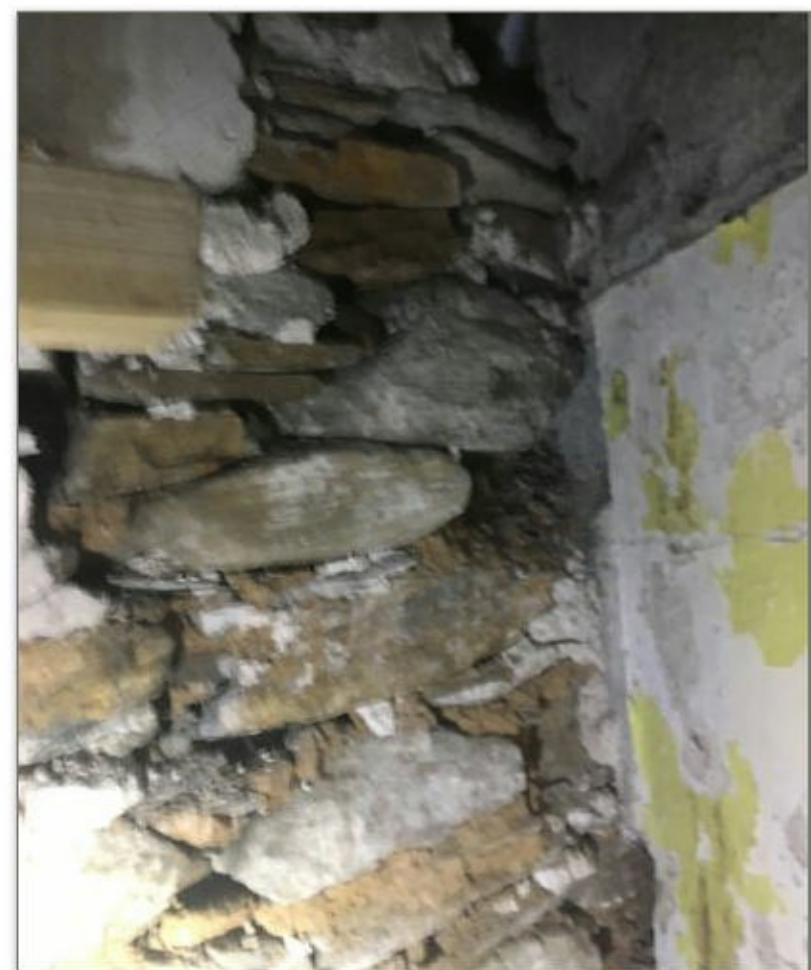
Pictures 4,5,6 Wall - Ground to wall gap draining rainwater directly onto the foundations at the rear elevation. Unsightly wall construction within the rear elevation.

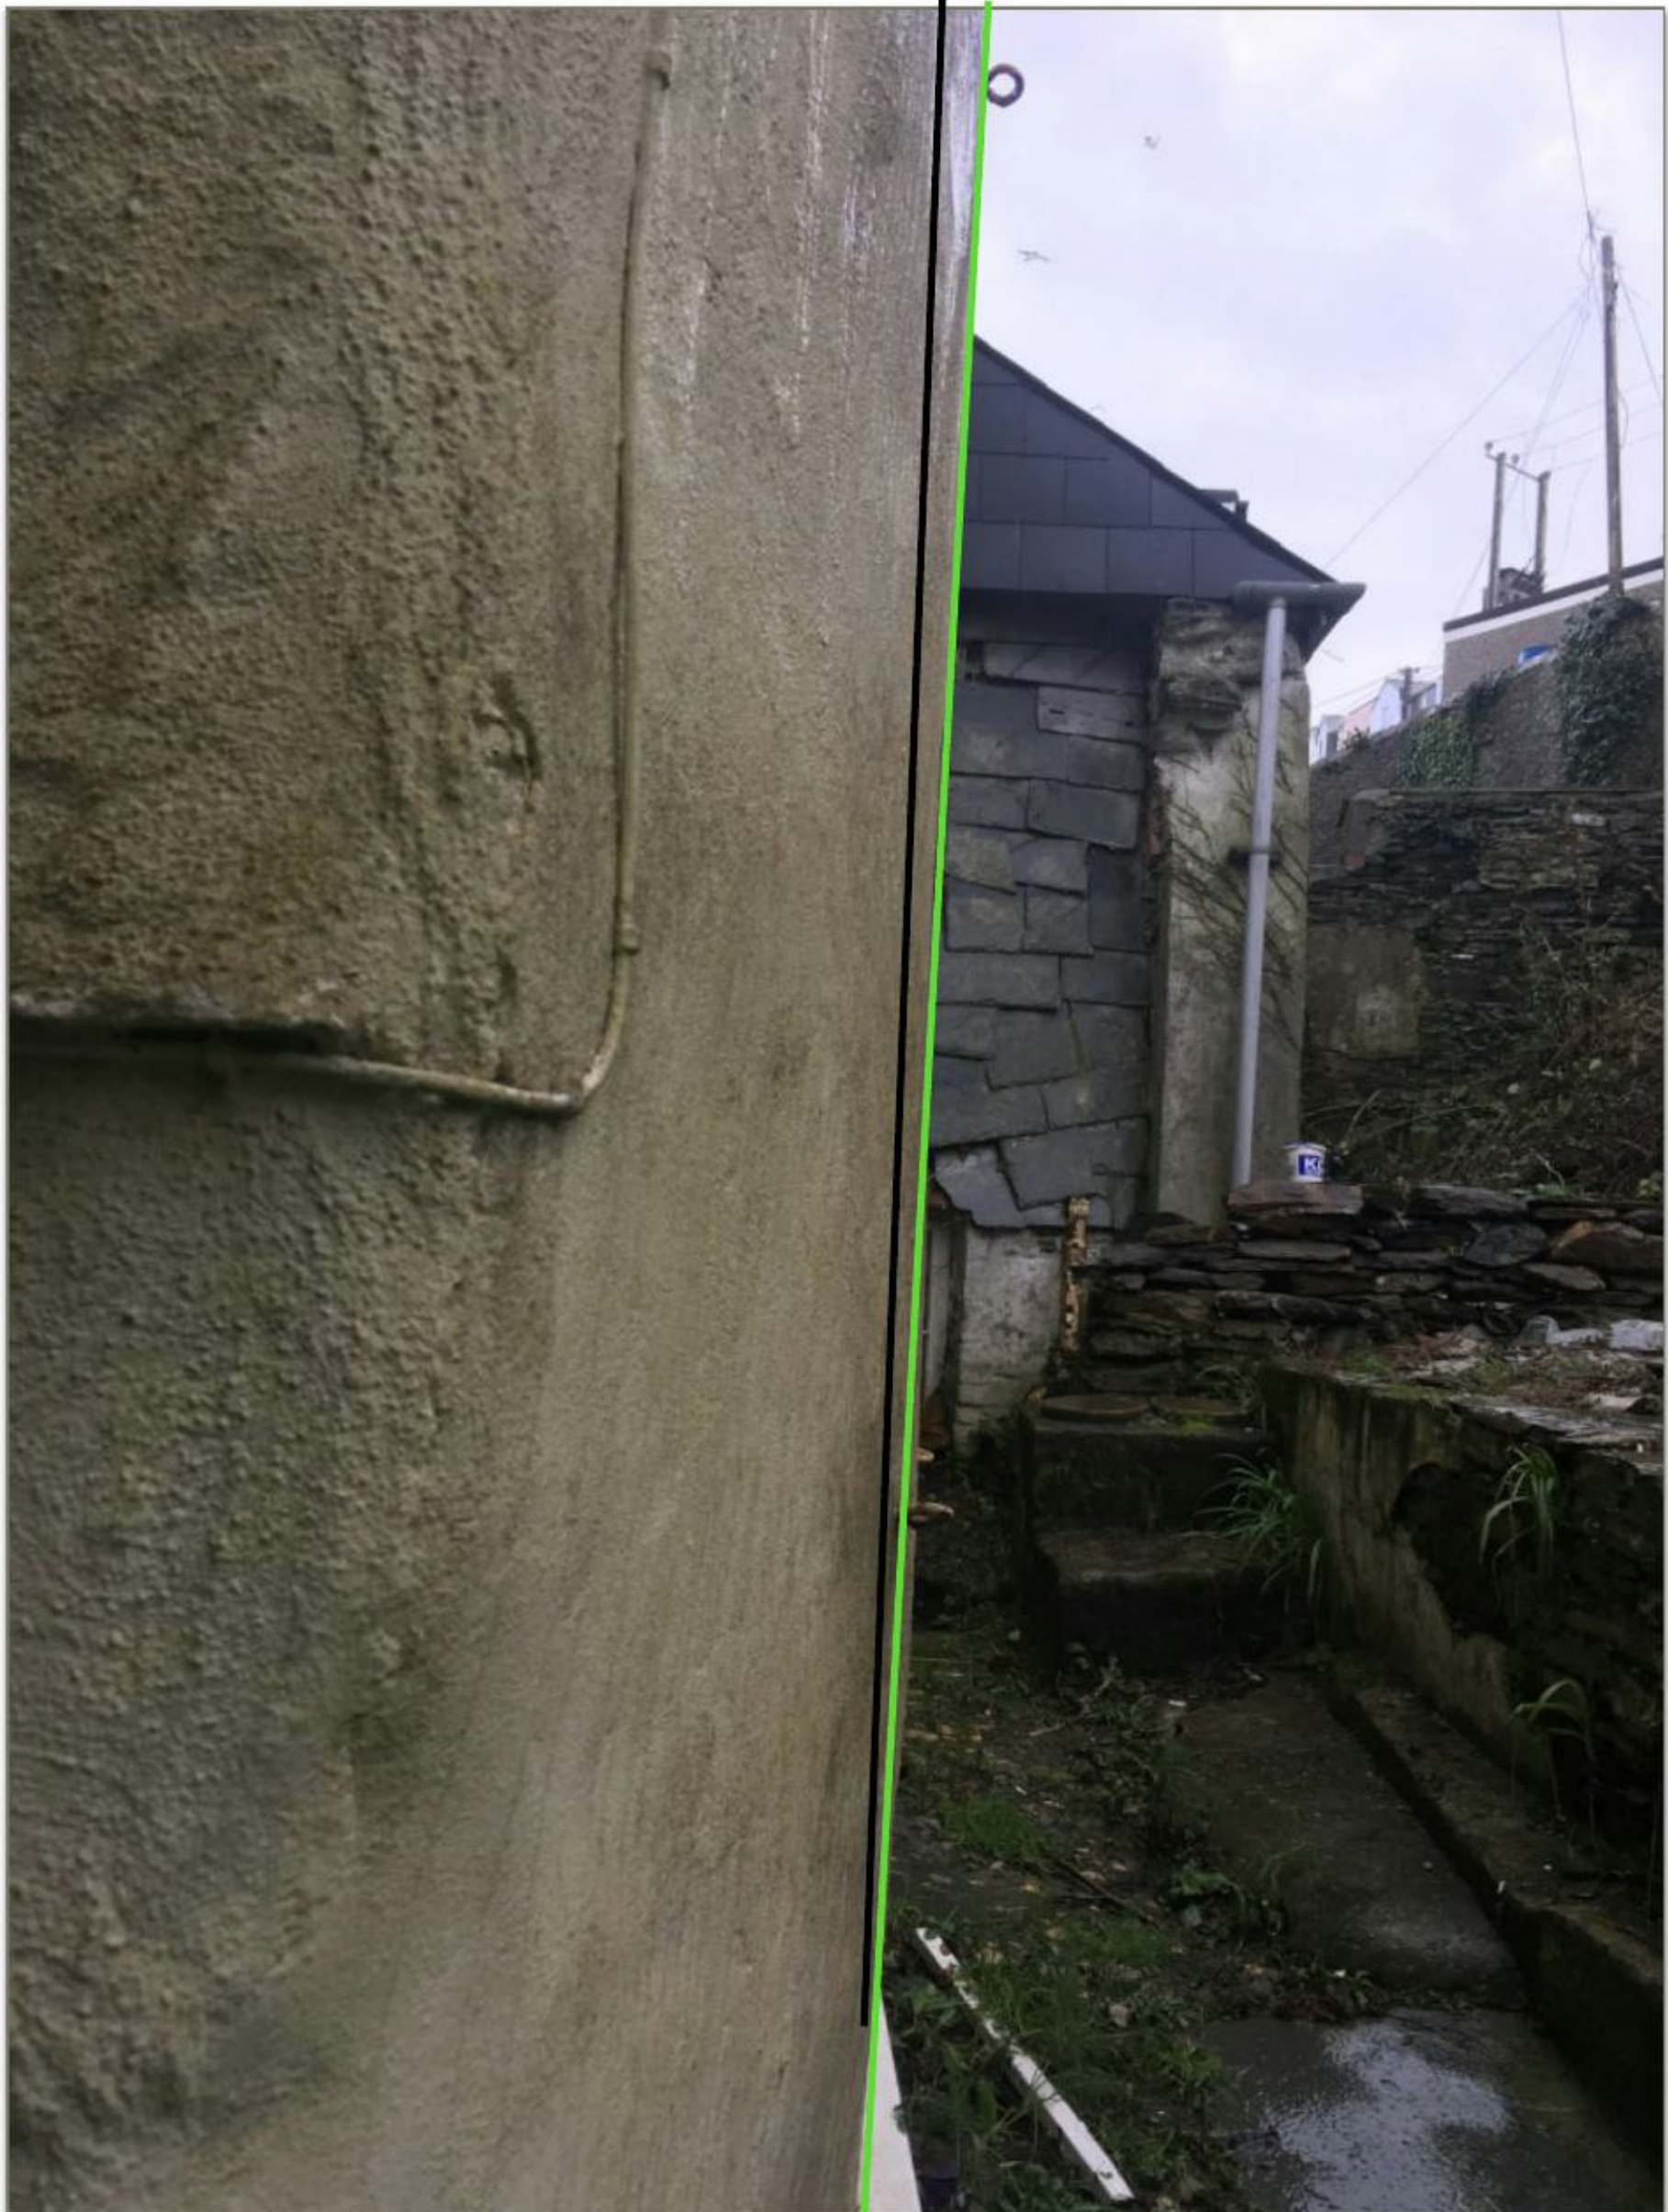
Picture 7 The rear elevation is leaning approximately 12 degrees  
(Note the black line is not vertical)

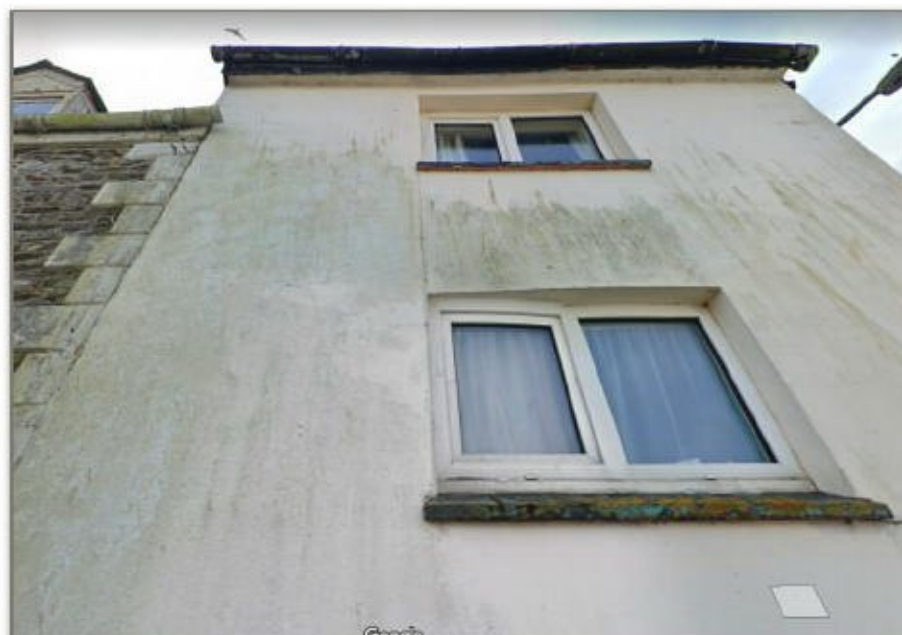
Picture 9 Front elevation. A recent picture free of structural damage

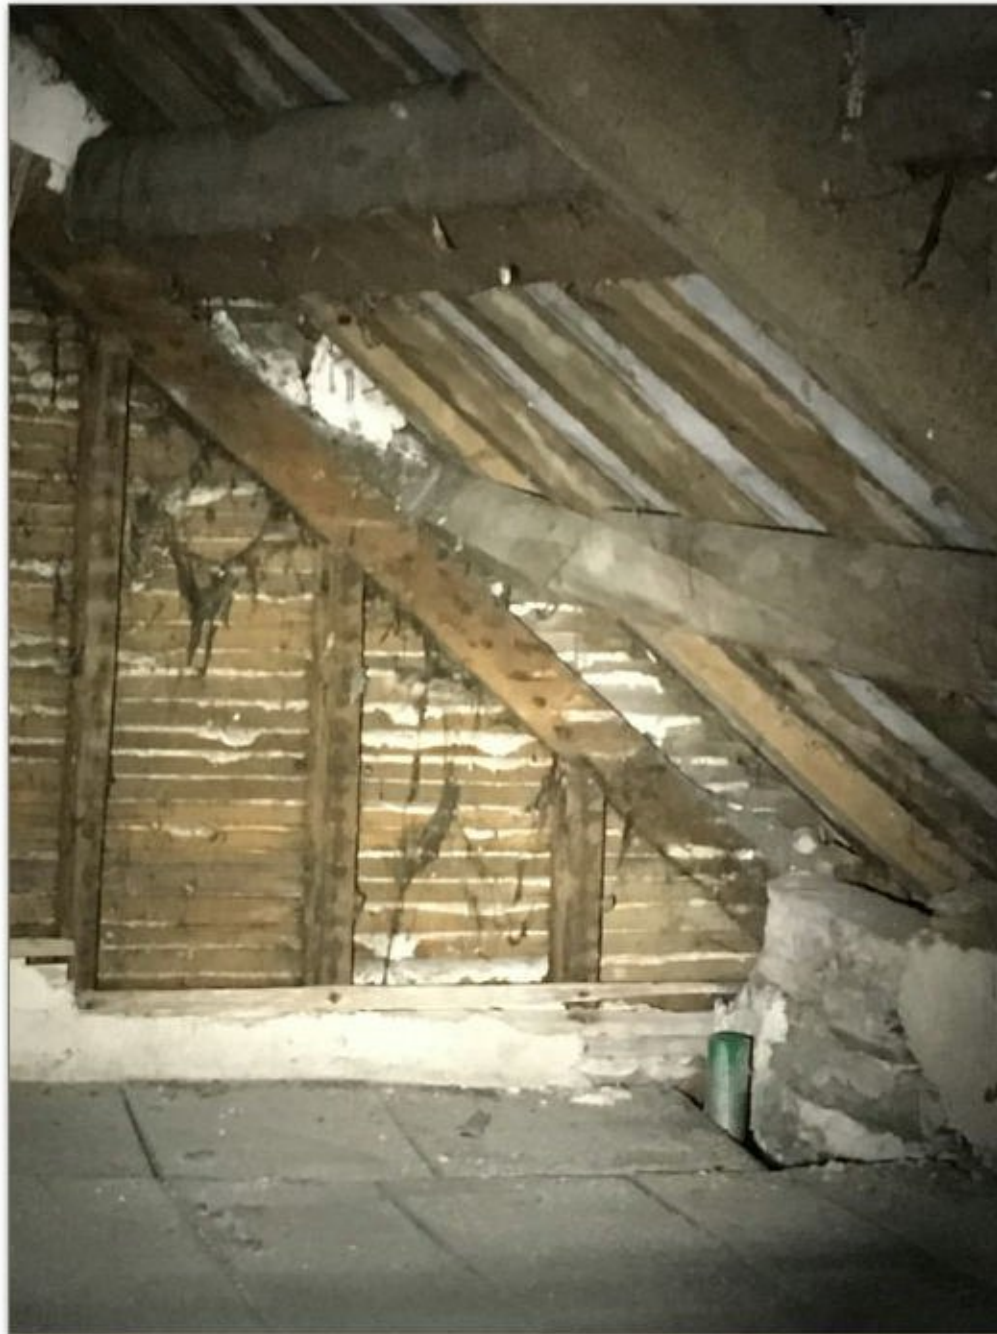
Picture 10 Split purling at the loft space, the roof is lacking vertical support. The rafters will spread outwards. Most of the timbers seem having gained moisture which seems to have halved their strength.

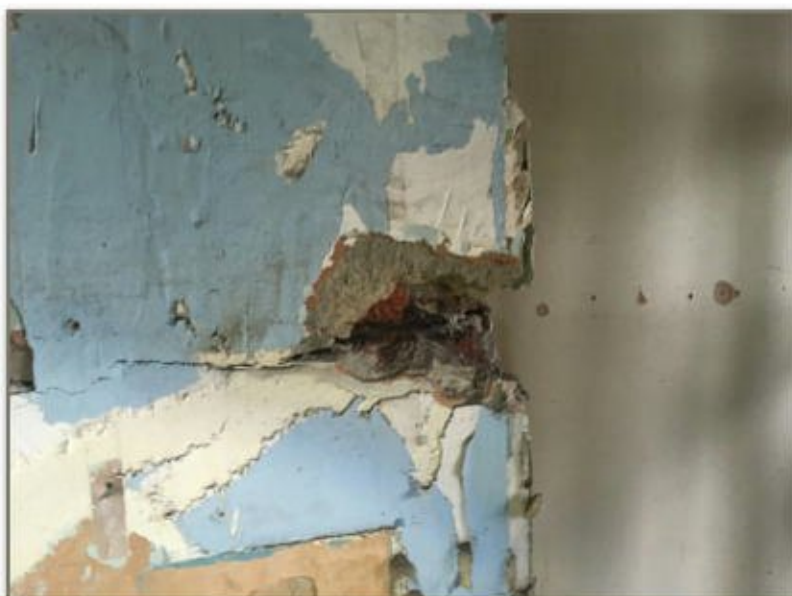
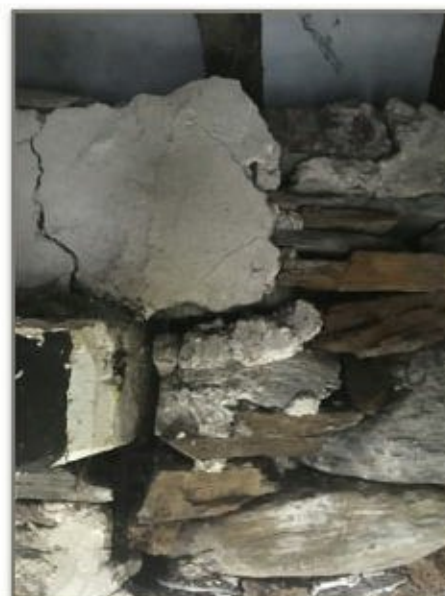
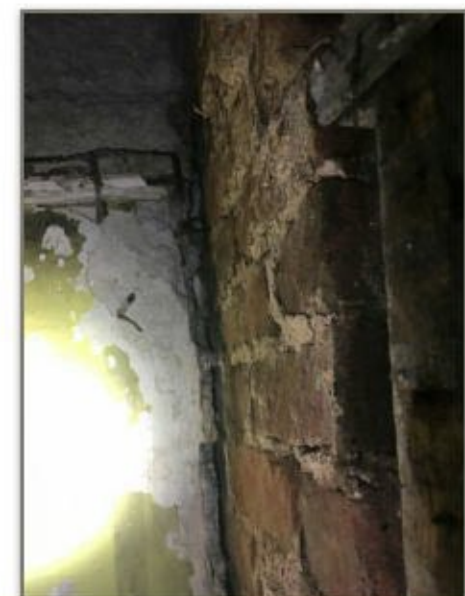
Pictures 11, 12, 13 damaged chimney breast. The integrity of the walls is degraded beyond repair.

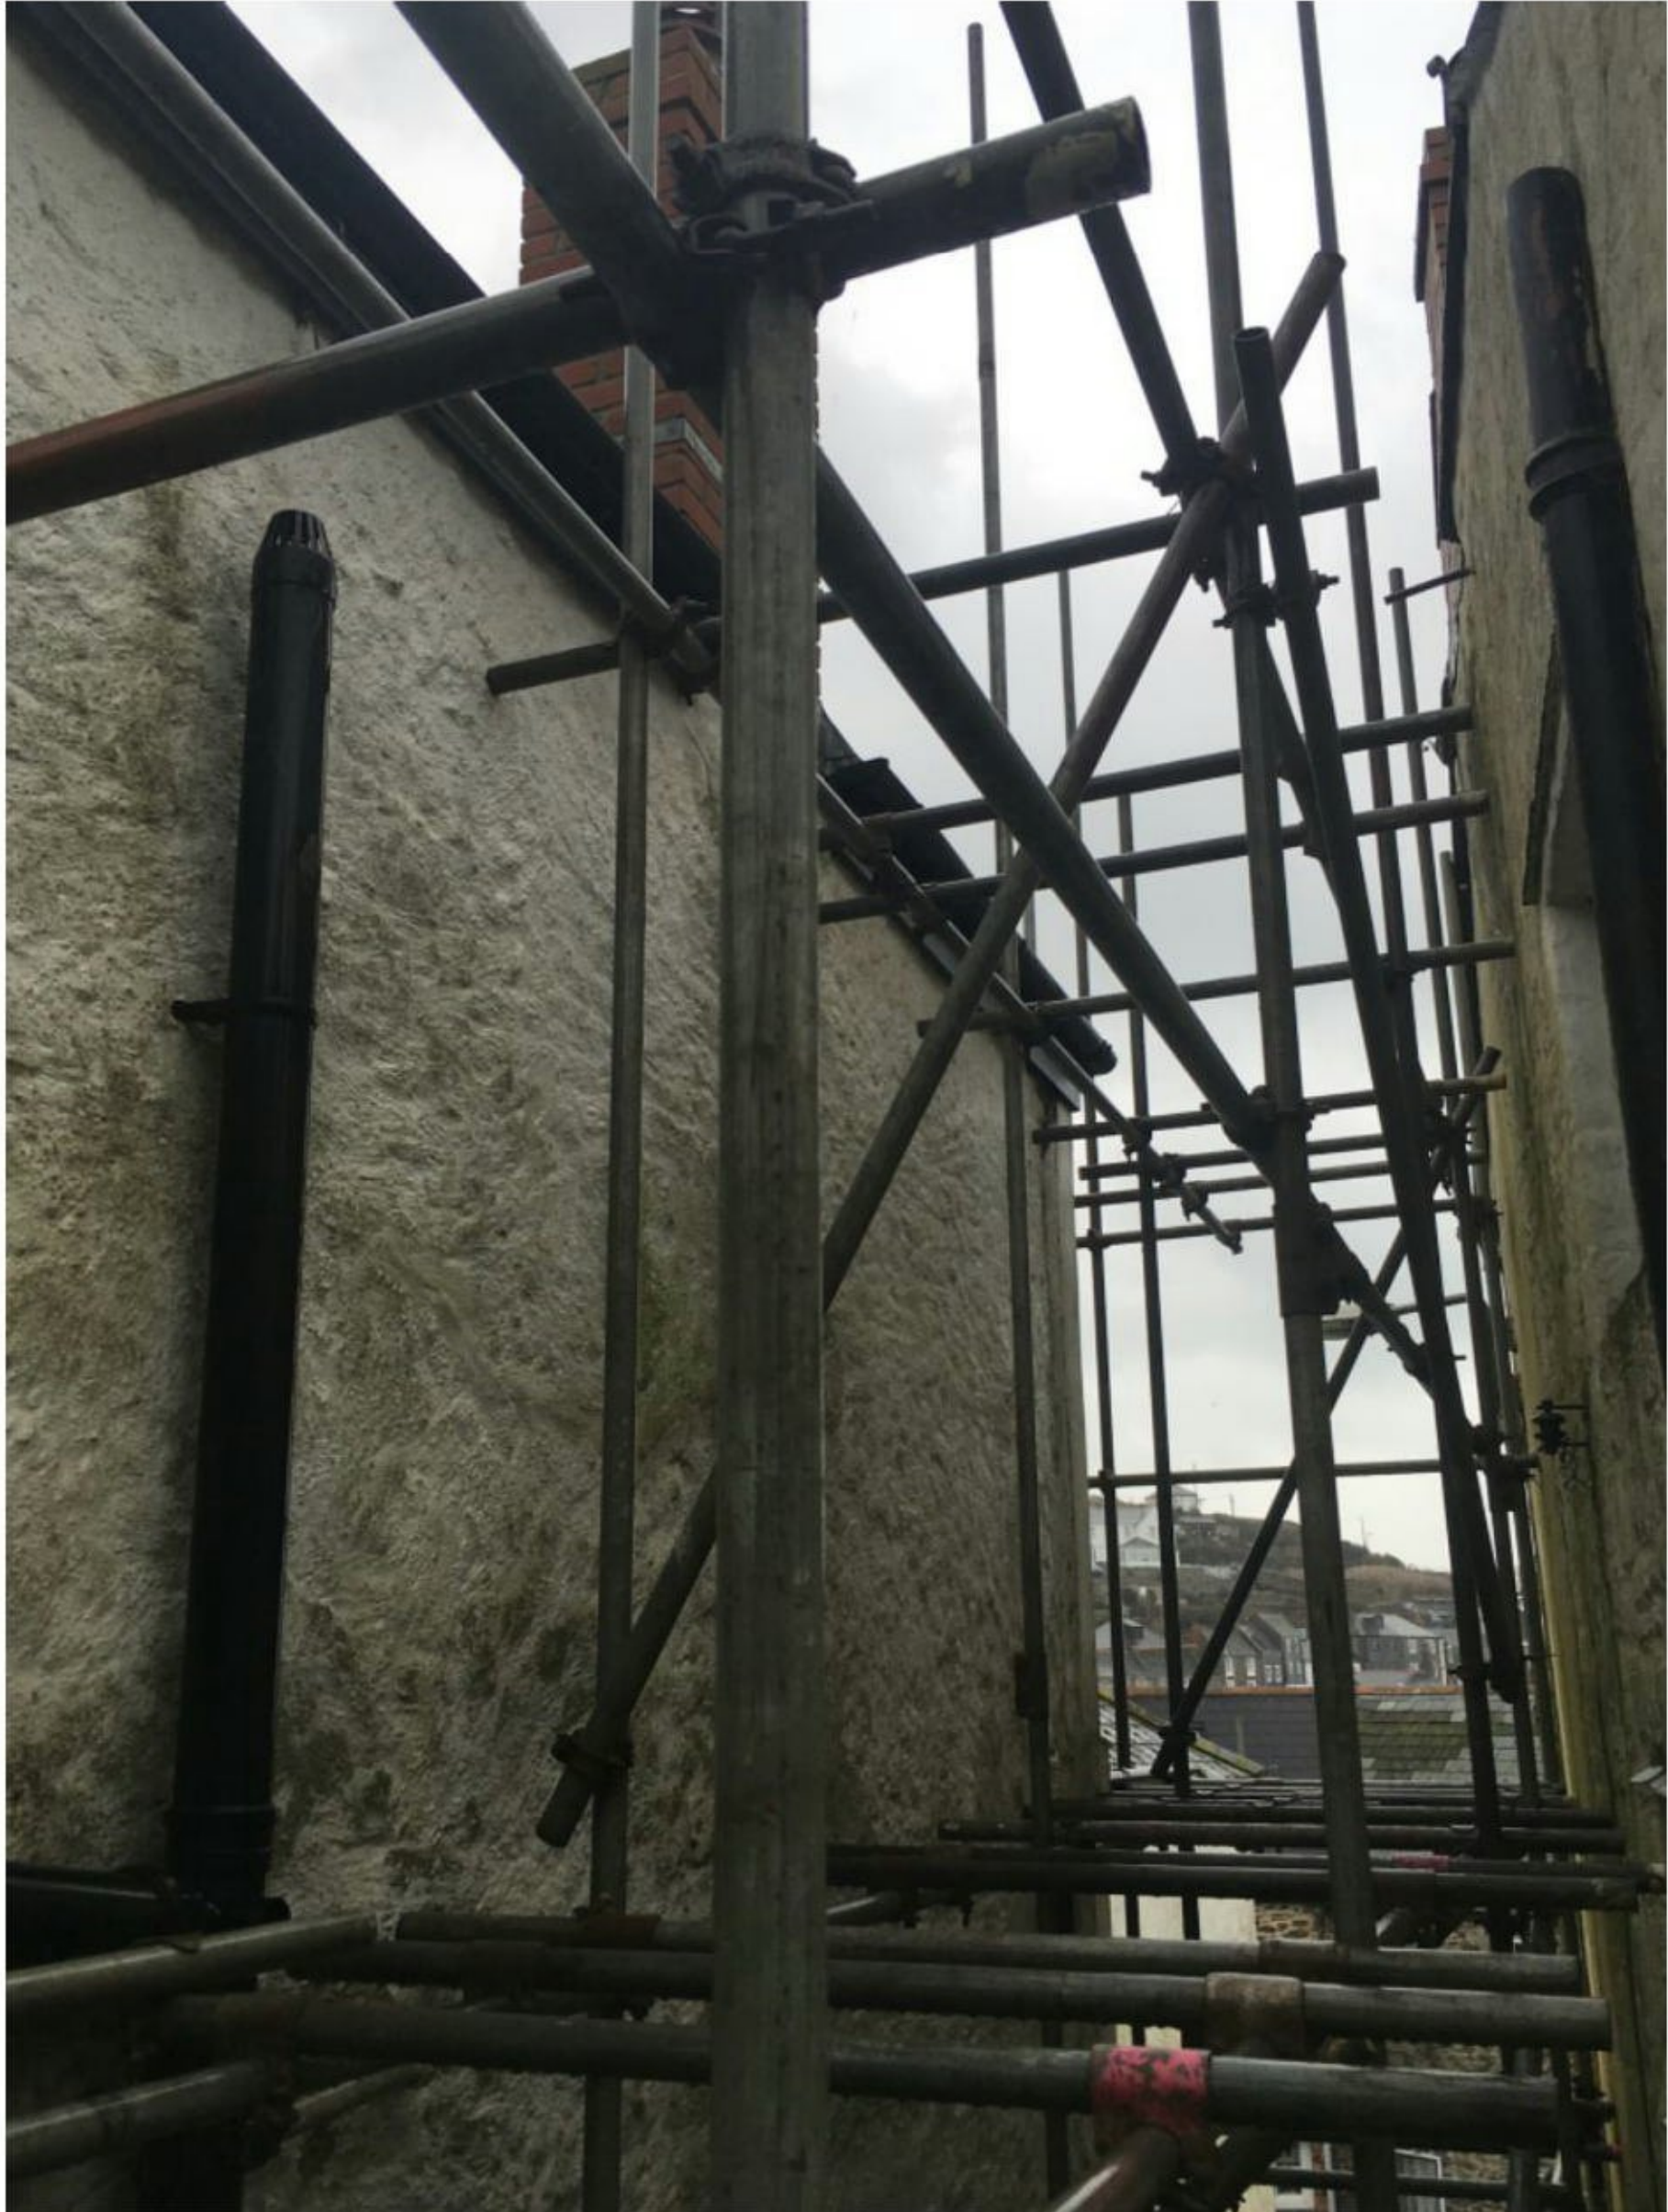
Picture 14 Scaffolding at the side elevation.  
Note the chimney stack was only renovated at the top.

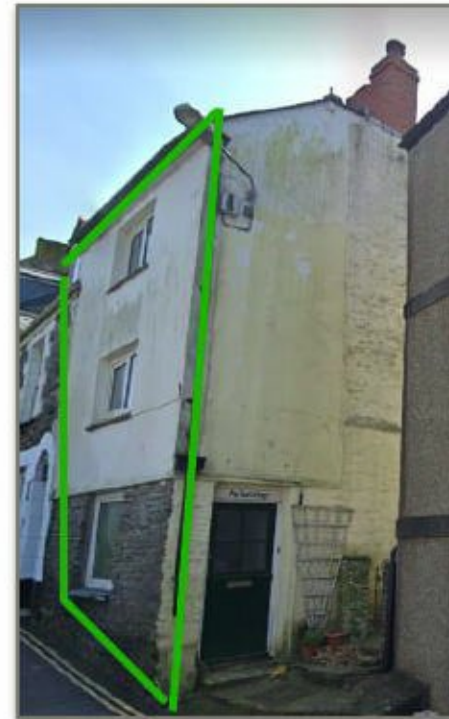
Ground floor level Shale wall, 500 mm thick with two storeys of block-work built on flat on top. Good Structural condition, tied to the nearby building. ✓

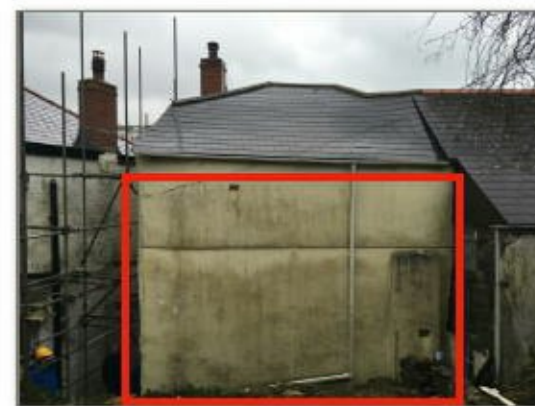
Fully rendered arrow shale wall with bell-cast joint at 2/3<sup>rds</sup> of its height. Wall leaning outwards towards the street. Roof on top partially sunken. Roof structure is lacking integrity and vertical supports. There is no practical way of supporting a rubble wall once its verticality has been lost, it will eventually come down in a dramatic manner. Given its size any temporary works to restrain the large mass of the wall would increase the wall weight or need their own foundations which would undermine the wall further. ✗

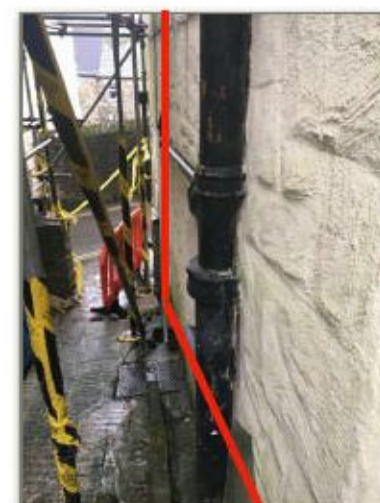
Pictures 15,16 ,17 showing the three elevations

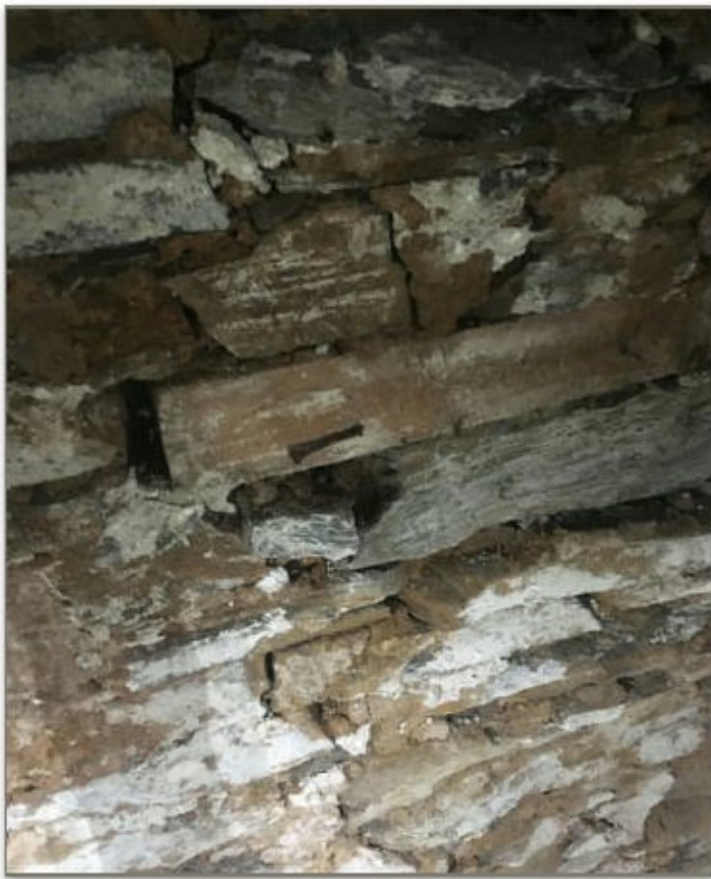
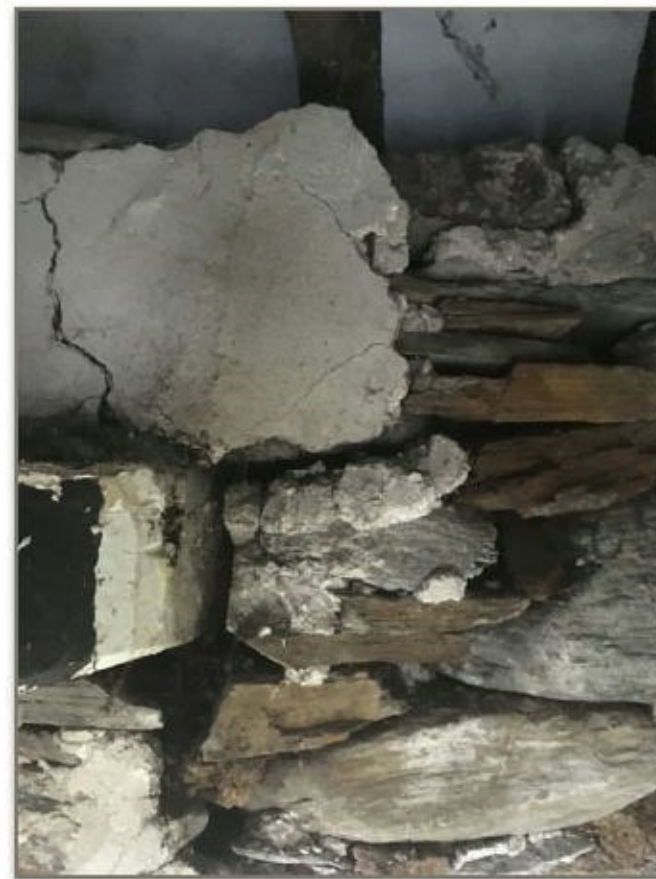
Pictures 18 -19 Rear wall internal detail. Non homogenous construction, cracks, uneven.

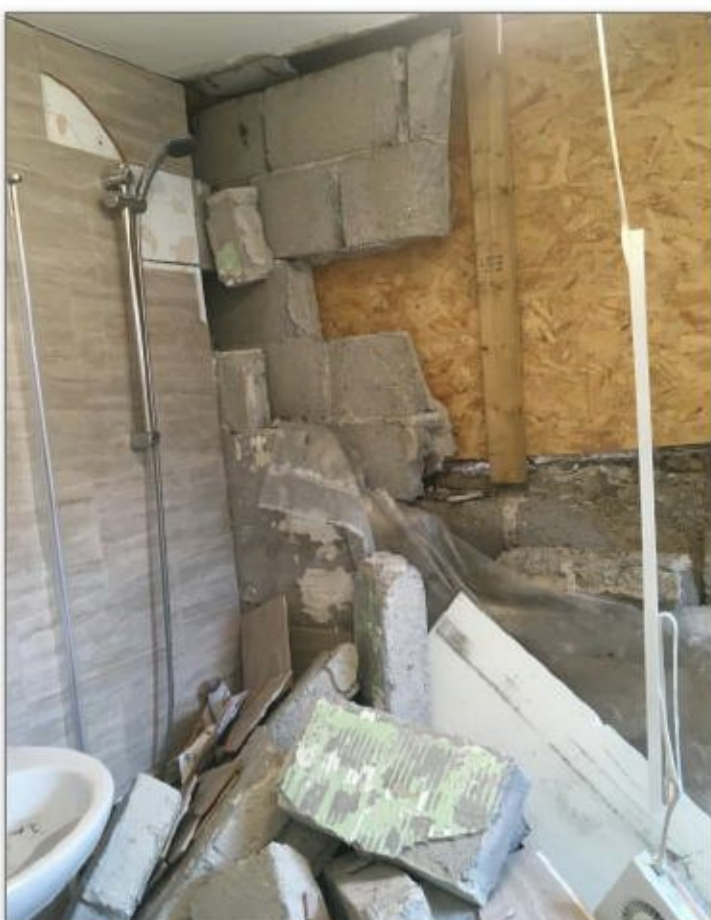
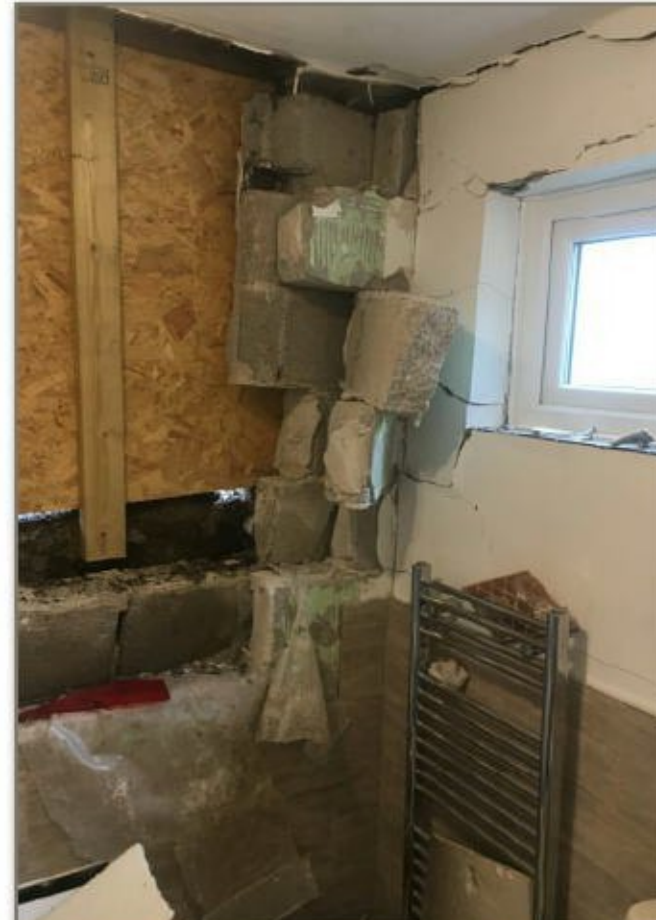
Pictures 20-21 A blockwork wall built without wall ties, hit by a van suffering an immediate collapse in Truro in February 2021
