Millard Home Inspections LLC  
1227 West Chester Dr  
Louisville, Ohio 44641  
David Millard Inspector  
330-265-6769

1234 somewhere Ave  
Town , Ohio 44321

## General Information

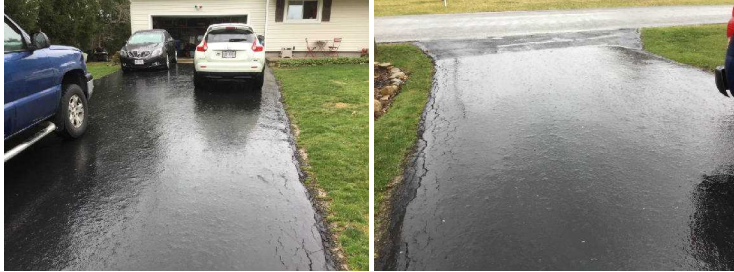
Driveway: Asphalt **Highly recommend sealing within one year to extend life and maintain appearance.**

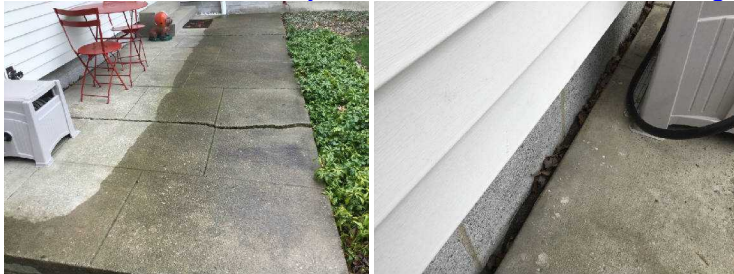
Porch: Concrete **Heavily cracked, Recommend sealing cracks to extend the life of the porch.**

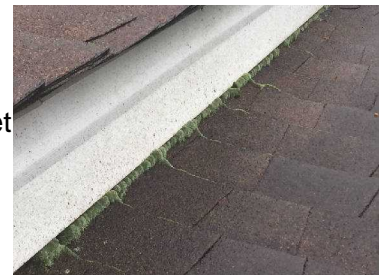
The shingles are comprised of asphalt or fiberglass materials impregnated with mineral granules that are designed to deflect the deteriorating ultra-violet rays of the sun. The most common of these roofs are warranted by manufacturers to last from fifteen to twenty-five years. The actual service life of the roof will vary, depending on a number of interrelated factors including the quality of the material and the method of installation. Regular maintenance will certainly extend the life of any roof. **Small amounts of moss present, recommend removal.**

**Though the moss itself does not hurt the roof, as the moss grows it can lift up shingles. During times of high winds the wind can get under the lift shingle and tear it off.**

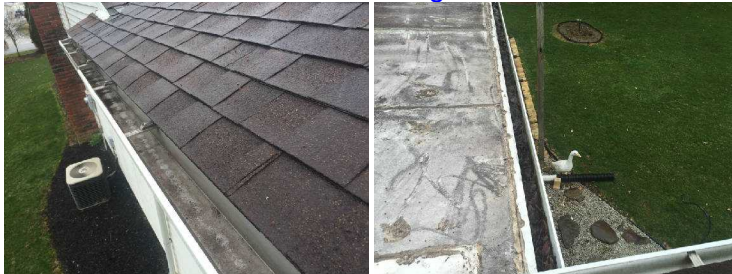
Gutters: Aluminum Need cleaning on the back sun room roof.

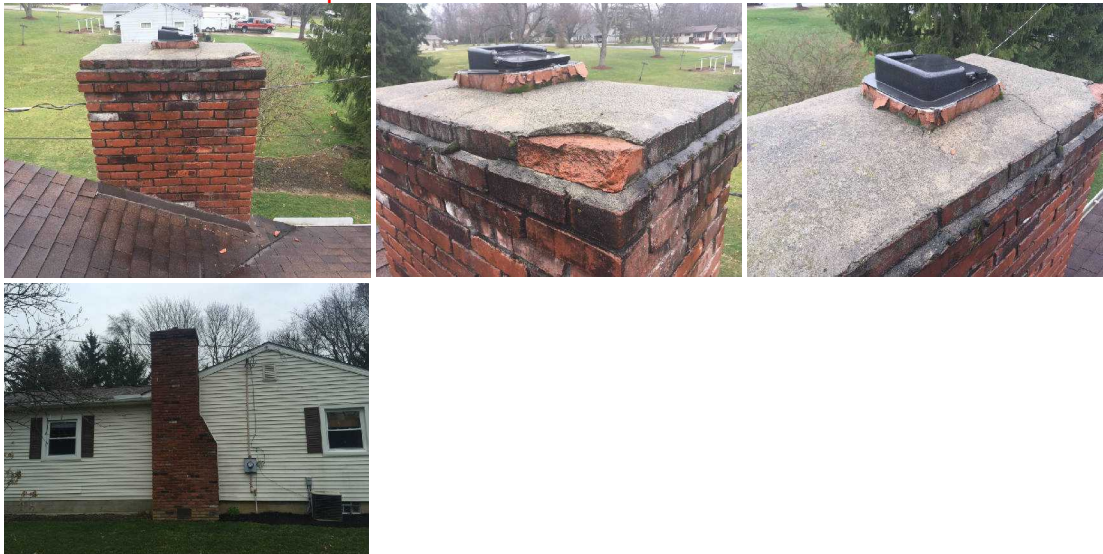
west Chimney

Chimney: Brick **Bricks have broken or popped surfaces- A qualified contractor is recommended to evaluate and estimate repairs**

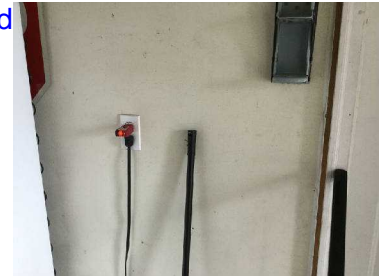
Electrical: 110 VAC outlets and lighting circuits **Non-GFCI circuit -recommend GFCI circuit be installed**

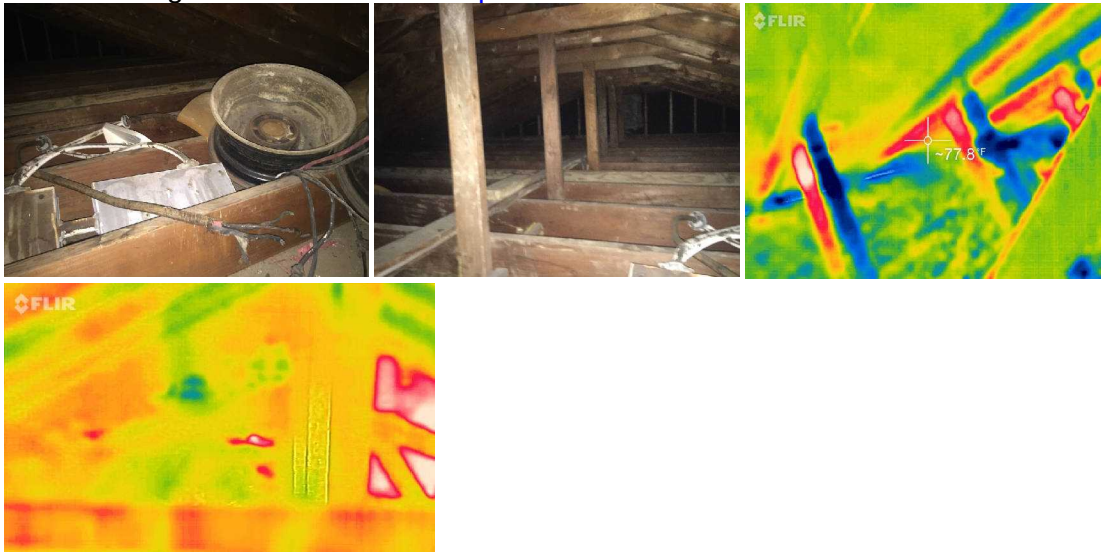
Roof Framing: 2x6 Rafter **Debree is present in the attic and should be removed.**

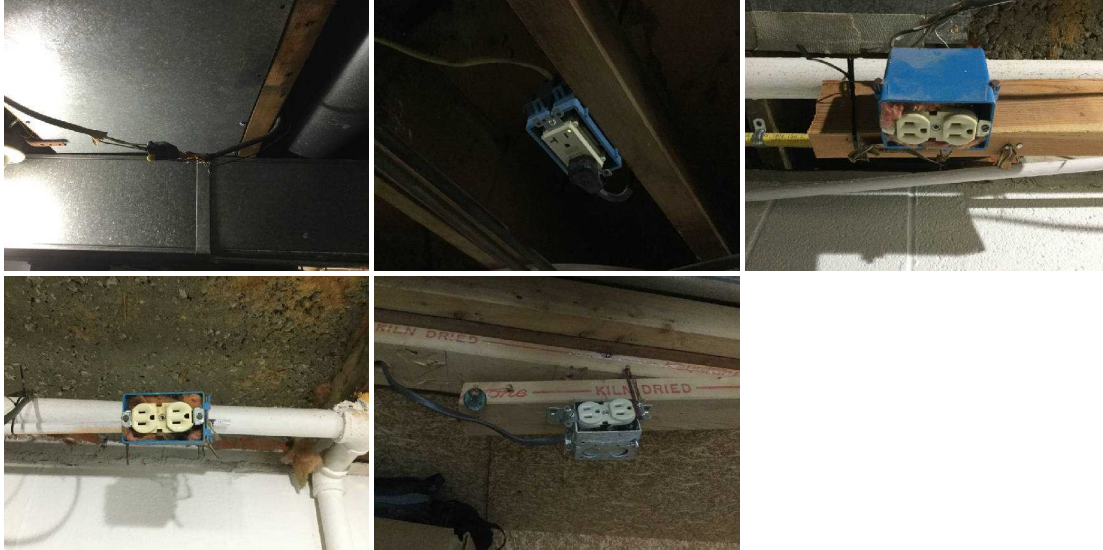
Electrical: 110 VAC outlets and lighting circuits **open splices, missing covers throughout basement** . A **licensed electrician is recommended to evaluate and estimate repairs**

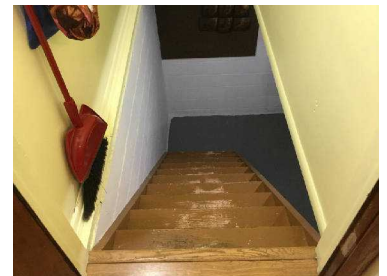
Basement Stairs/Railings: Wood stairs with no handrails

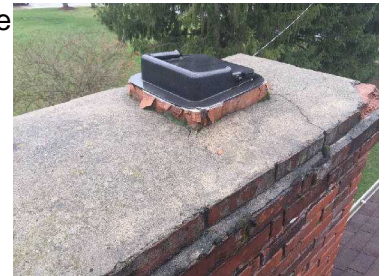
Damper: Metal The old flue rusted away and a new one has been fitted at the top of the chimney on the roof.

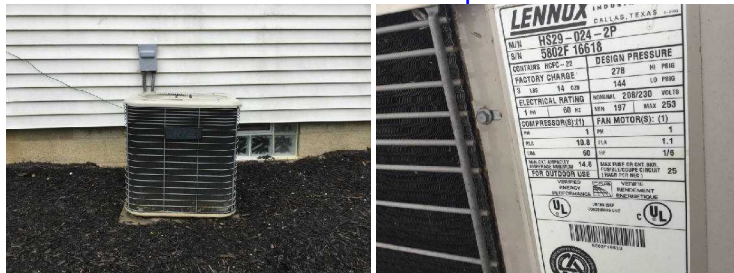
The unit should be leveled for best performance and to avoid possible damage .

The outside condenser unit needs to be monitored to make sure it is and stays level. A unit that rests on the ground can begin to settle and become off level. A unit should be no more than 2 inches off level to prevent damage to the unit.

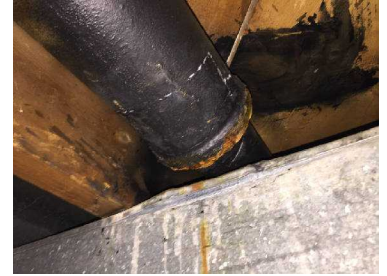
Drain Pipes: PVC and cast iron **Connection from cast iron to PVC by the furnace is leaking and will need repaired.**

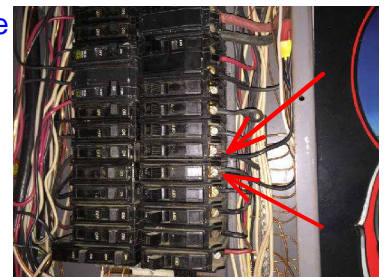
Maximum Capacity: 200 Amps  
 Main Breaker Size: 200 Amps  
 Breakers: Copper and Aluminum **Double taps are present at breakers. These circuits need to be moved to their own circuit breaker and cannot share a breaker. It is recommended that a qualified electrician inspect the new circuits and properly connect the new circuits to an individual breaker for each circuit**

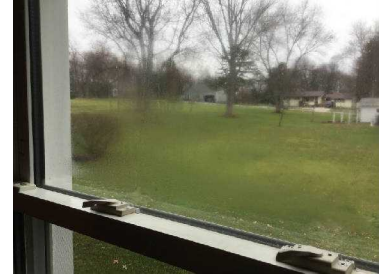
Windows: Vinyl double hung **Moisture present inside the layers of glass.**

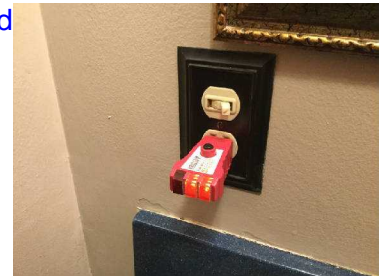
Doors: Hollow wood  
Windows: Wood double hung  
Electrical: 120 VAC outlets and lighting circuits **Non-GFCI circuit -recommend GFCI circuit be installed**

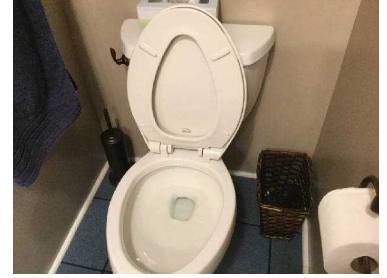
Toilets: Kohler [The tank is loose](#)

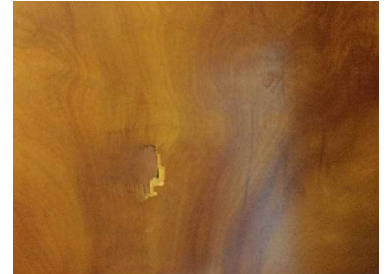
Bedroom 1 rear east Bedroom  
Closet: Single **Minor damage to closet door**

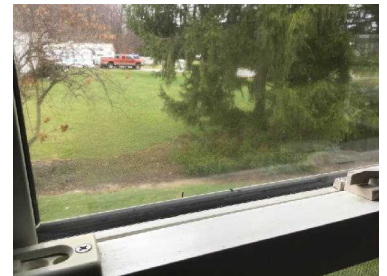
Ceiling: Drywall  
Walls: Paint  
Floor: Laminate wood  
Doors: French  
Windows: Vinyl double hung [Moisture present inside the layers of glass](#)

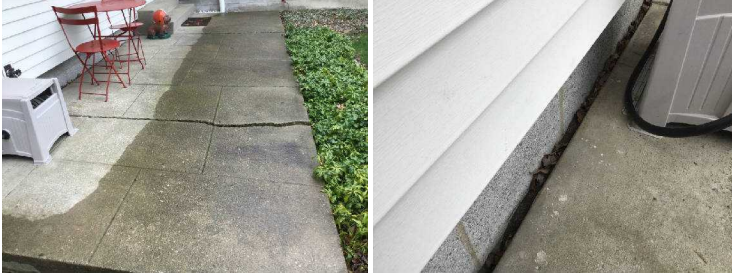
1. Porch: Concrete **Heavily cracked, Recommend sealing cracks to extend the life of the porch.**

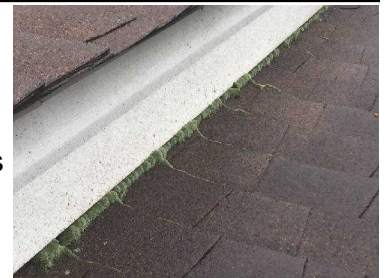
**Small amounts of moss present, recommend removal.**

**Though the moss itself does not hurt the roof, as the moss grows it can lift up shingles. During times of high winds the wind can get under the lift shingle and tear it off.**

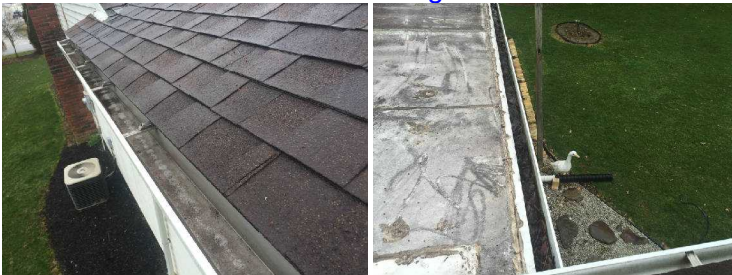
3. Gutters: Aluminum **Need cleaning on the back sun room roof.**

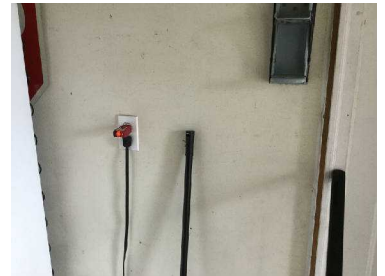
6. Attached Garage Electrical: 110 VAC outlets and lighting circuits  
Non-GFCI circuit -recommend GFCI circuit be installed

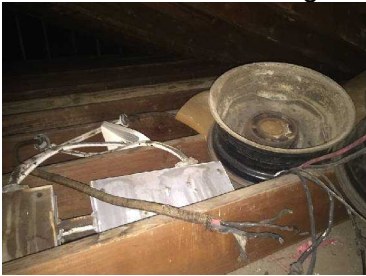
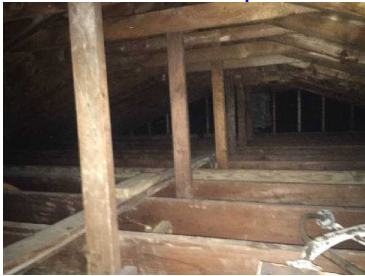
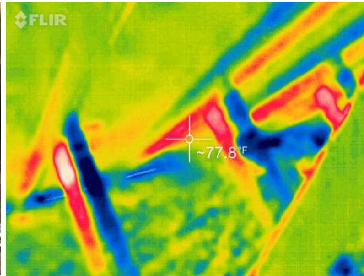
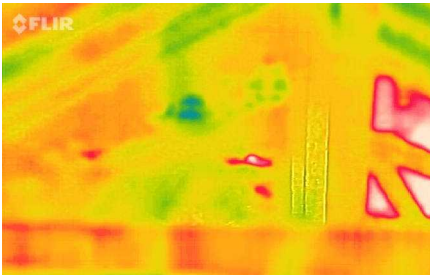
8. Main Attic Roof Framing: 2x6 Rafter Debree is present in the attic and should be removed.

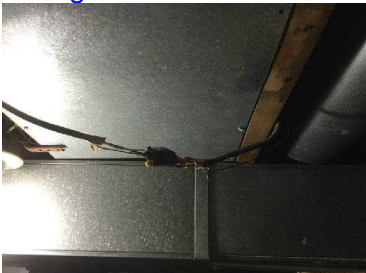
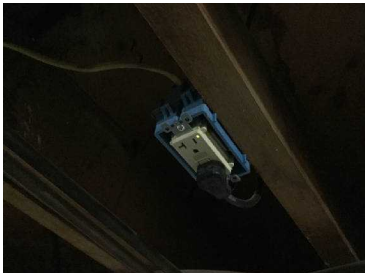
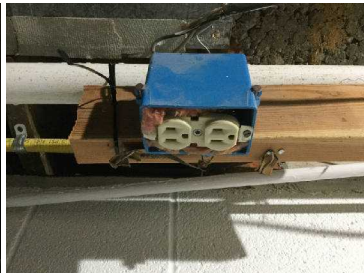
9. Main Basement Electrical: 110 VAC outlets and lighting circuits open splices, missing covers throughout basement . A licensed electrician is recommended to evaluate and estimate repairs

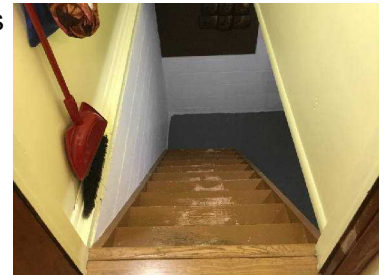
10. Main Basement Basement Stairs/Railings: Wood stairs with no handrails

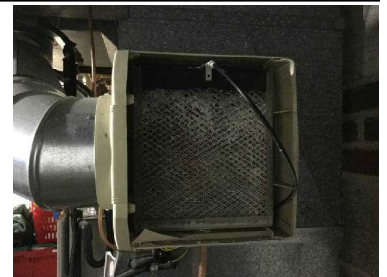
11. Basement Heating System Humidifier: April-Aire Needs cleaning

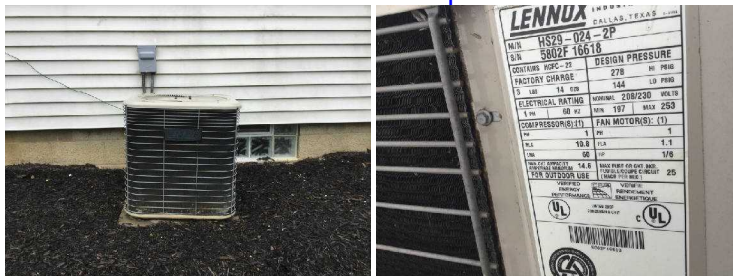
12. Main AC System A/C System Operation: Appears serviceable To avoid possible compressor damage due to outside temperature below 60 degrees, the unit was not tested. The unit should be leveled for best performance and to avoid possible damage .

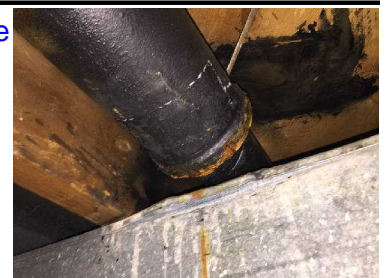
13. Drain Pipes: PVC and cast iron Connection from cast iron to PVC by the furnace is leaking and will need repaired.

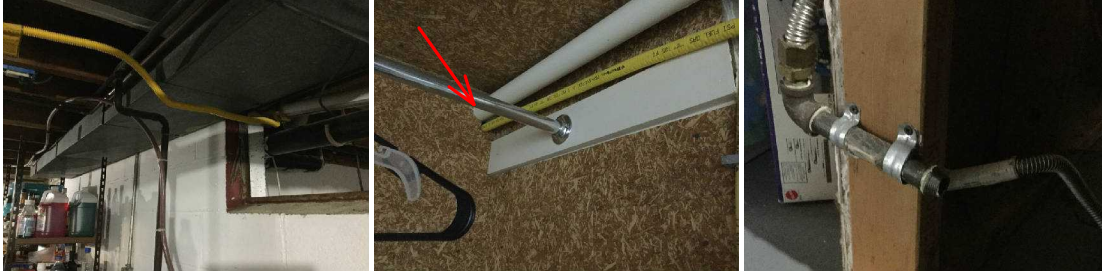
14. Gas Service Lines: Cast iron and flexible Flexible gas lines should not pass through walls. The end of the pipe is open just pass the shut off where an appliance has been disconnected. This is a safety issue, A cap Should be put on the end of the open pipe.

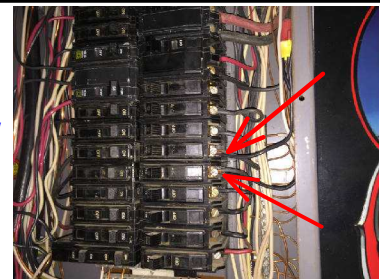
15. Basement Electric Panel Breakers: Copper and Aluminum Double taps are present at breakers. These circuits need to be moved to their own circuit breaker and cannot share a breaker. It is recommended that a qualified electrician inspect the new circuits and properly connect the new circuits to an individual breaker for each circuit

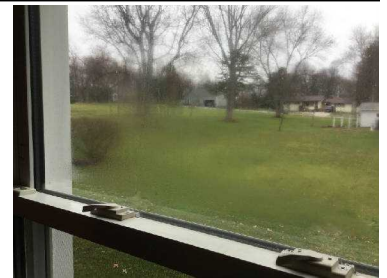
17. Dining Room Living Space Windows: Vinyl double hung Moisture present inside the layers of glass.

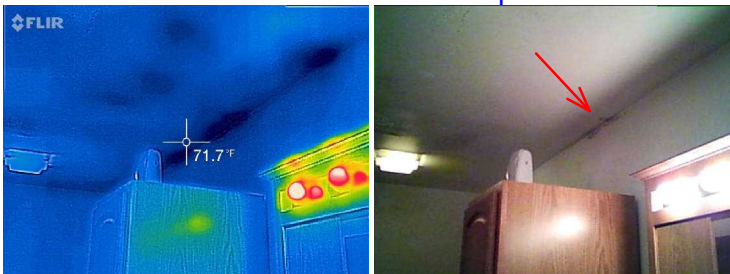
18. Bathroom 1 main Bathroom Ceiling: Drywall ceilings Microbial growth is present and is a potential health concern. Damp areas on the ceiling found with thermal camera and confirmed with moisture meter. Removal and/or correction is required.

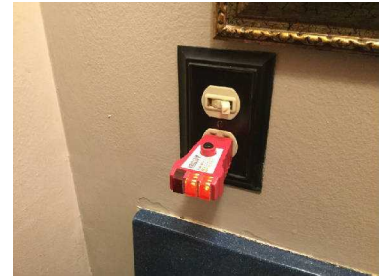
19. Bathroom 1 main Bathroom Electrical: 120 VAC outlets and lighting circuits **Non-GFCI circuit -recommend GFCI circuit be installed**

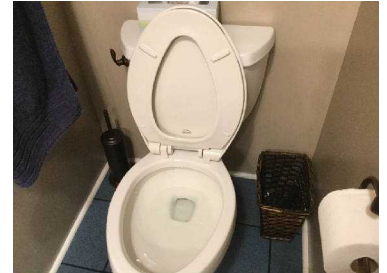
20. Bathroom 1 main Bathroom Toilets: Kohler **The tank is loose**

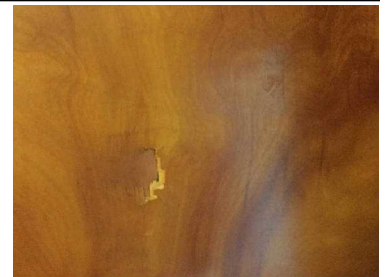
21. Bedroom 1 rear east Bedroom Closet: Single **Minor damage to closet door**

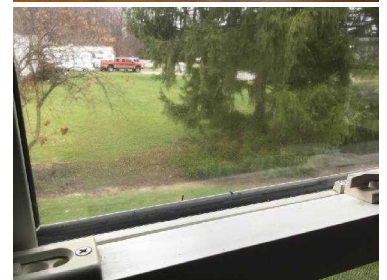
22. Bedroom 3 front Bedroom Windows: Vinyl double hung **Moisture present inside the layers of glass**

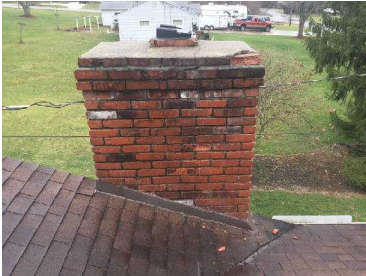
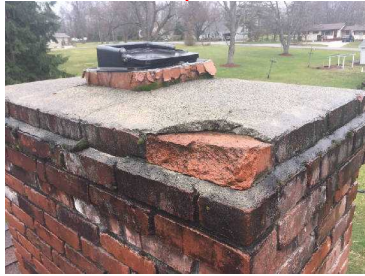
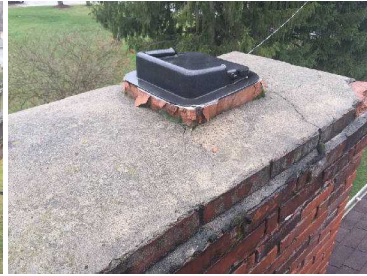
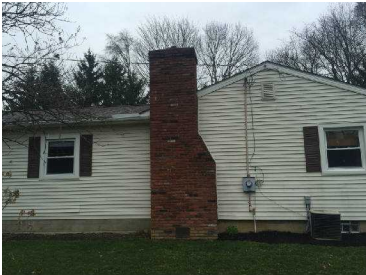
1. west Chimney Chimney: Brick Bricks have broken or popped surfaces- A qualified contractor is recommended to evaluate and estimate repairs
