On 13/9/2022 the undersigned Stefano Pisano was commissioned by [REDACTED] to evaluate the condition of the vessel in question in order to proceed with the purchase.

MODEL : MARITIMO 500 OFFSHORE NAME : [REDACTED]
LOA :16,50 MT MAX BEAM : 5,2 MT DRAFT : 1,2 MT
BUILDER : MARITIMO YACHTS - AUSTRALIA
HULL NUMBER : [REDACTED]
ITALIAN REGISTER : [REDACTED]
MATERIAL : G.R.P. YEAR: 2009
ENGINES : 2X CATERPILLAR C12 - 715 HP
NUMBERS : [REDACTED]
PEOPLE : CAT A 16
OMOLOGAZIONE CE : A
EMPTY DISPLACEMENT : 21.000 KG
DIESEL CAPACITY: 3500 LT ca
TANK MATERIAL : STAINLESS STEEL
FRESH WATER CAPACITY: 800 LT ca
TANK MATERIAL : STAINLESS STEEL
GENERATOR : CATERPILLAR 17,5 KW
BATTERIES : 8 X 225 AMPERE
OUTBOARD : MERCURY 9,9 CV 4 STROKE
DINGHY : ZODIAC 3,10 MT PVC

Pre purchase survey

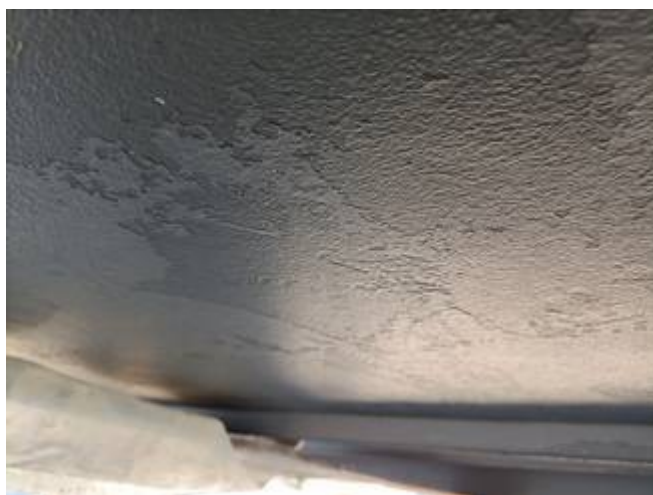
At the time of the inspection, the boat was hauled after sea trials. No marine relevant concretions or plant residues were present. The surface of the hull due to the presence of antifouling paint was not smooth; as declared by the owner the paint was applied on 2022 May however there were different badly distributed layers applied by roller.

Figura 2: antifouling not homogeneous

New antifouling after removing all old layers.

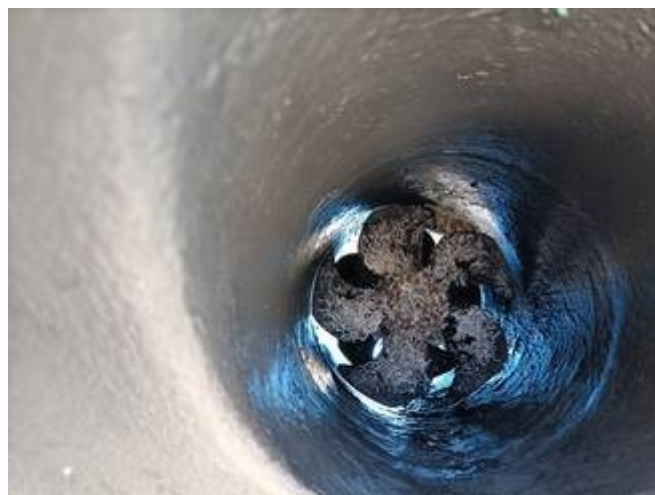
The craft was fitted with a bow and a stern thruster. The tubes were firmly glassed in the hull and the edges of the apertures were well sealed; the propellers were intact even if marine concretions were on the plastic propellers.

Figura 1: bow thruster propeller to clean

Change anods of hull and of bow and stern thrusters.

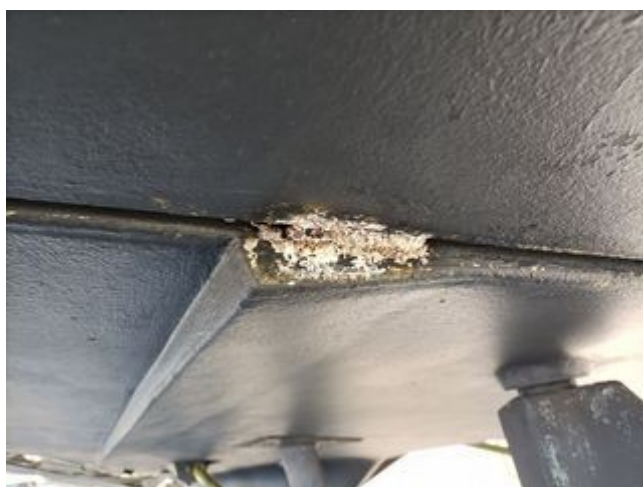
The Flaps were working properly, some concretions were found on the hinges.

Figura 4: flaps hinges to clean

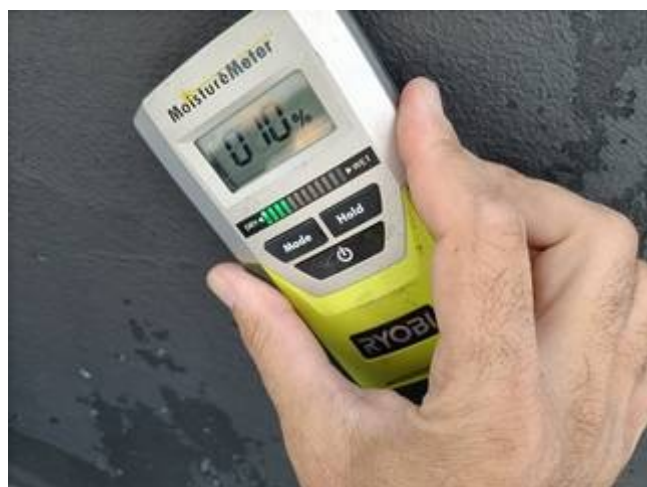
The values found below the waterline were normal (10%-12%)

Figura 3: hygrometer value

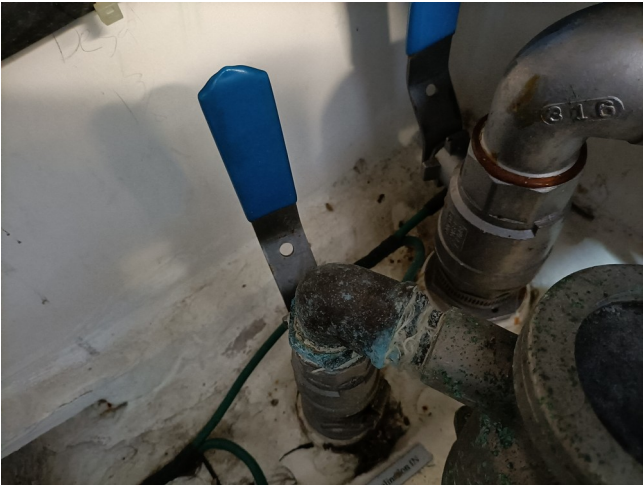
Only one elbow (see photo) not steel of the air conditioning seacocks showed deterioration but still in working conditions. Same thing happened to the bronze water filter of same circuit.

Figura 6: a/c seacock elbow

It is recommended maintenance and lubrication for all valves to keep them operable..

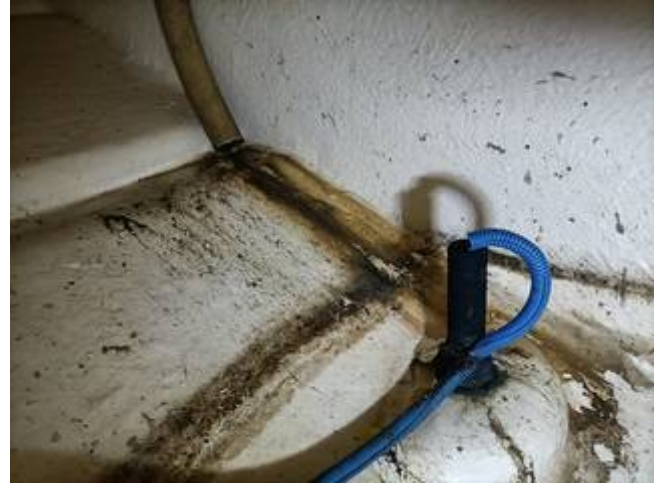
The bilges between two central cabins were not dry with a little dirty cameled from grey tank circuit.

Figura 5: central bilge some dirty from grey tank

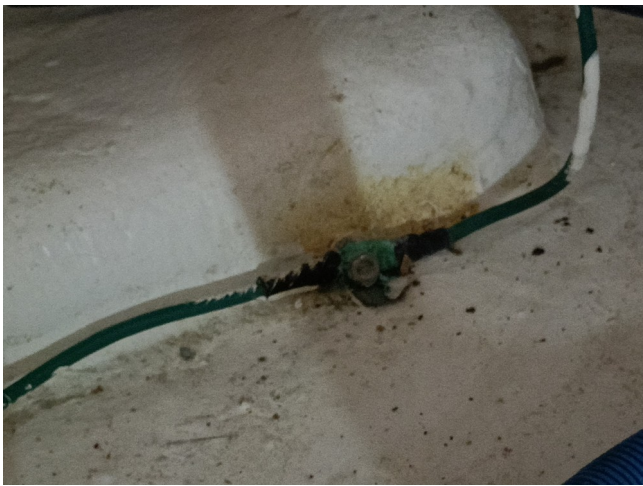
- radar out of order
- plotters lcd screen deteriorated
- some oxidation on ground wires found from inside in the bow area close to the left rudder
- dinghy

Figura 8: ground wire with few oxid- left stern

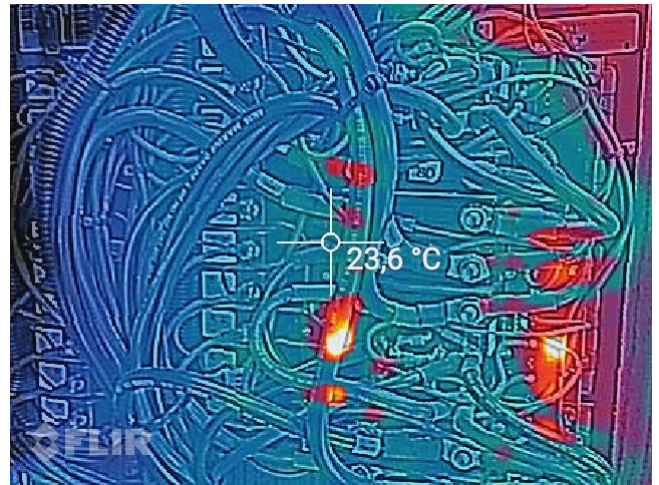
Figura 7: thermal camera inspection for electric panel

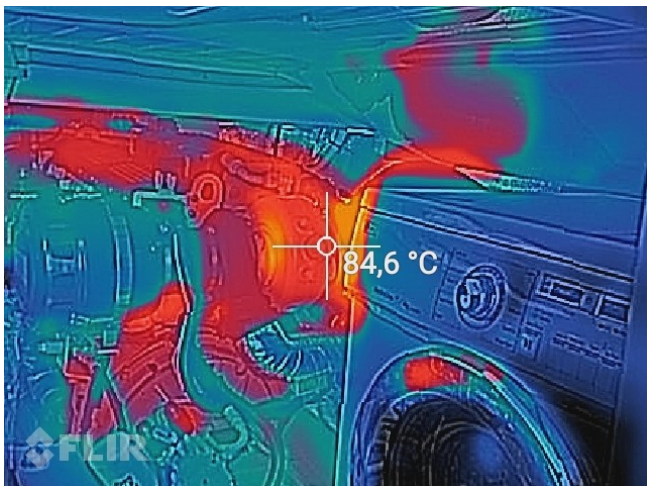
no anomaly detected

Figura 9: thermal camera inspection right engine

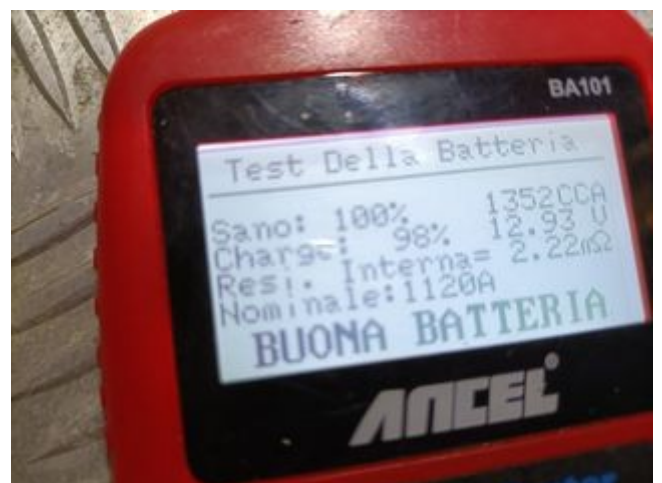
The batteries of both the services and the engines were tested with the electronic instrument Ancel, which gave a positive result both for the state of use and for the state of charge.

Figura 10: batteries test
