Millard Home Inspections LLC  
1227 West Chester Dr  
Louisville, Ohio 44641  
David Millard Inspector  
330-265-6769

1234 somewhere Ave  
Town , Ohio 44321

## General Information

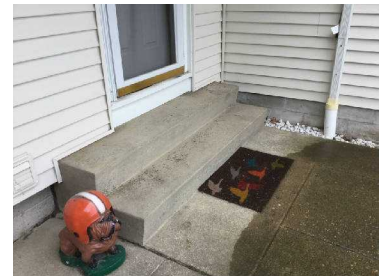
Porch: Concrete **Heavily cracked, Recommend sealing cracks to extend the life of the porch.**

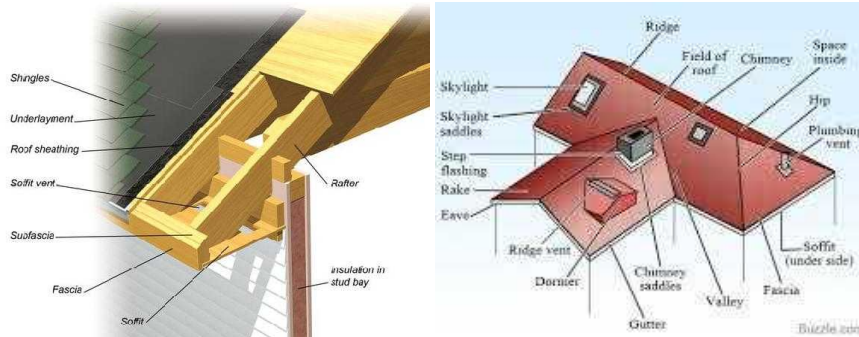
The shingles are comprised of asphalt or fiberglass materials impregnated with mineral granules that are designed to deflect the deteriorating ultra-violet rays of the sun. The most common of these roofs are warranted by manufacturers to last from fifteen to twenty-five years. The actual service life of the roof will vary, depending on a number of interrelated factors including the quality of the material and the method of installation. Regular maintenance will certainly extend the life of any roof. **Small amounts of moss present, recommend removal.**

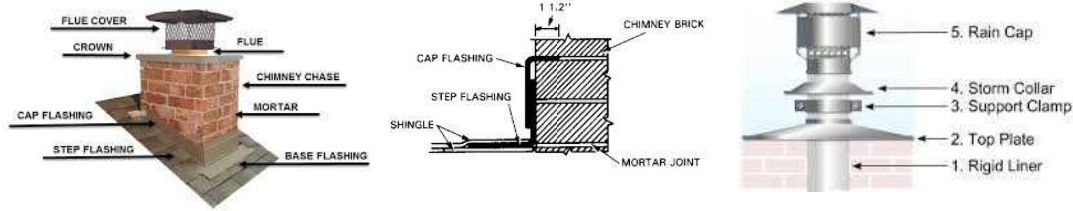
west Chimney

Chimney: Brick **Bricks have broken or popped surfaces- A qualified contractor is recommended to evaluate and estimate repairs**

Crown: mortar **The crown is cracked and/or deteriorating and should be repaired. Silicone and sealant are not correct repairs on chimney crowns. These types of repairs are prone to moisture penetration causing areas to pop and crack.**

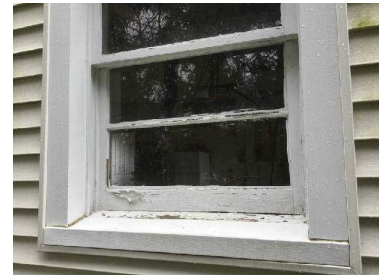
Smoke Detector: Battery operated with light  
Windows: Wood double hung **Flaking peeling paint present, should be scraped and painted.**

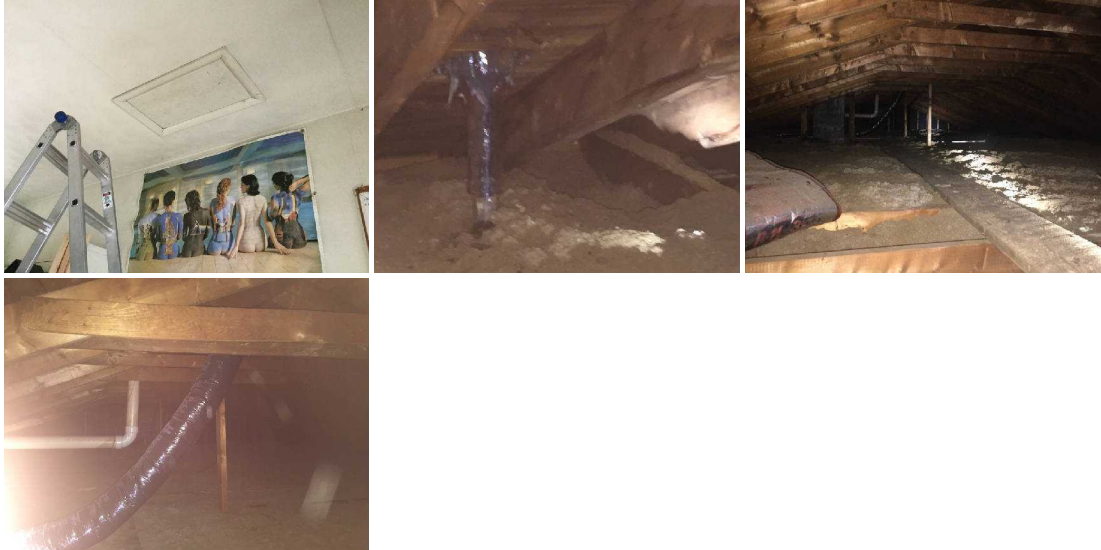
According to the U.S. Department of Energy, an attic access that is not insulated is a big hole and deficiency in the thermal barrier between the attic and conditioned space. This gap in the attic insulation increases heat loss in the winter and heat gain in the summer. An unsealed attic access can potentially leak the same amount of air supplied by a typical bedroom heating duct (~100 CFM). To insulate an attic access, a lightweight, moveable box or panel can be constructed from rigid foam to fit over the access from the attic side. For more information, visit [www.eere.energy.gov](http://www.eere.energy.gov).

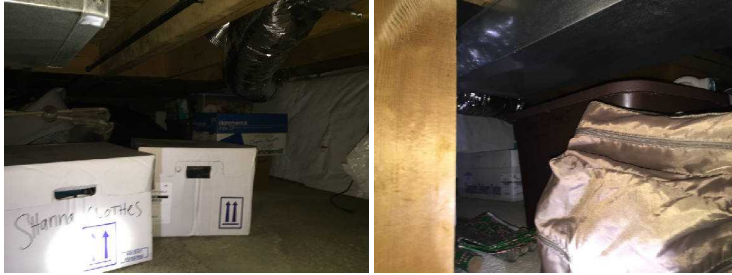
Crawlspace Restrictions: The crawlspace should be cleaned out for further inspection prior to closing.

Unable to Inspect: 50% Storage boxes

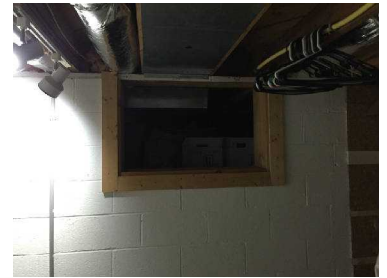
Moisture Penetration: Moisture present under the entire home.

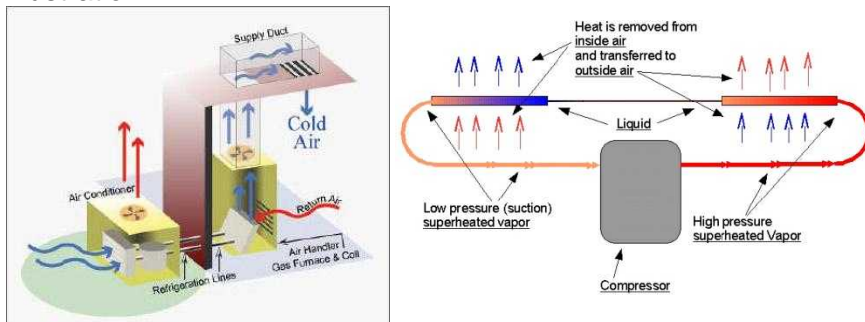
A/C System Operation: Appears serviceable To avoid possible compressor damage due to outside temperature below 60 degrees, the unit was not tested.

The unit should be leveled for best performance and to avoid possible damage .

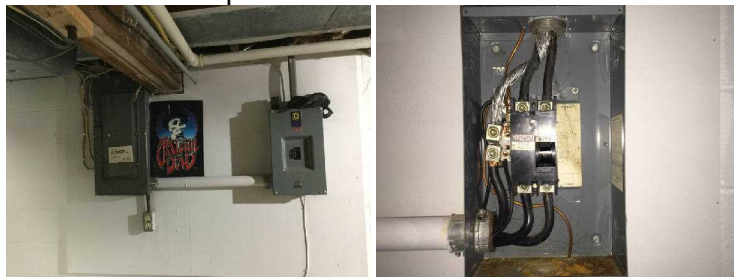
Maximum Capacity: 200 Amps  
 Main Breaker Size: 200 Amps  
 Breakers: Copper and Aluminum **Double taps are present at breakers. These circuits need to be moved to their own circuit breaker and cannot share a breaker. It is recommended that a qualified electrician inspect the new circuits and properly connect the new circuits to an individual breaker for each circuit**

15. Basement Electric Panel Breakers: Copper and Aluminum Double taps are present at breakers. These circuits need to be moved to their own circuit breaker and cannot share a breaker. It is recommended that a qualified electrician inspect the new circuits and properly connect the new circuits to an individual breaker for each circuit

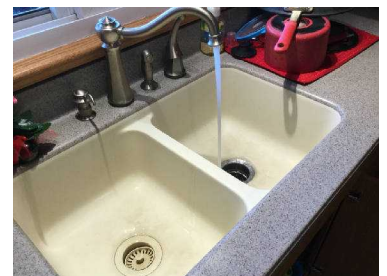
Fixtures: Moen **The handle for the water is loose making shutting the water off difficult. Should be corrected or replaced.**

16. 1st Floor Kitchen Fixtures: Moen The handle for the water is loose making shutting the water off difficult. Should be corrected or replaced.

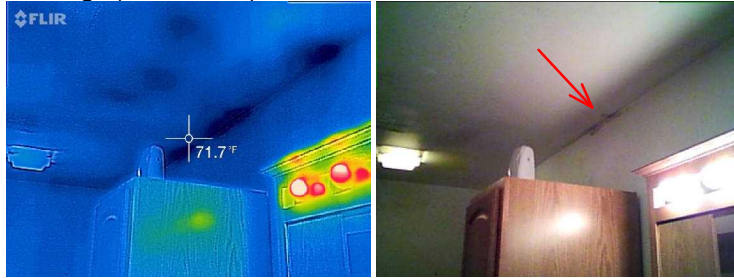
Ceiling: (continued)

Ceiling: Drywall ceilings **Microbial growth is present and is a potential health concern. Damp areas on the ceiling found with thermal camera and confirmed with moisture meter. Removal and/or correction is required.**

18. Bathroom 1 main Bathroom Ceiling: Drywall ceilings Microbial growth is present and is a potential health concern. Damp areas on the ceiling found with thermal camera and confirmed with moisture meter. Removal and/or correction is required.

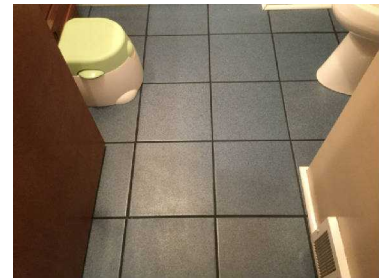
Doors: Hollow wood  
Windows: Wood double hung  
Electrical: 120 VAC outlets and lighting circuits **Non-GFCI circuit -recommend GFCI circuit be installed**

19. Bathroom 1 main Bathroom Electrical: 120 VAC outlets and lighting circuits **Non-GFCI circuit -recommend GFCI circuit be installed**

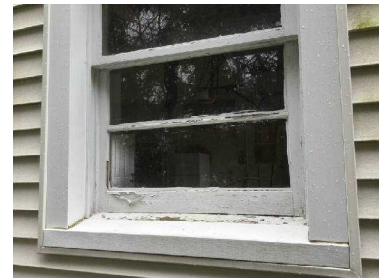
7. Attached Garage Windows: Wood double hung Flaking peeling paint present, should be scraped and painted.

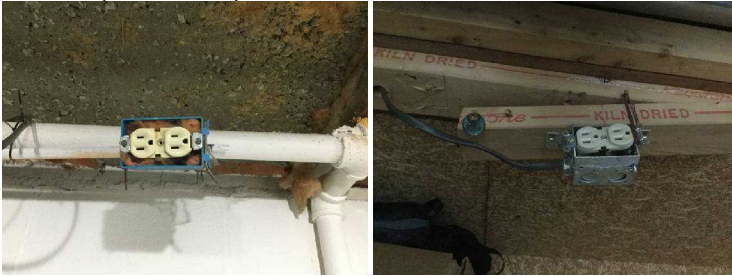
Electrical: (continued)

9. Main Basement Electrical: 110 VAC outlets and lighting circuits open splices, missing covers throughout basement . A licensed electrician is recommended to evaluate and estimate repairs
